Official information request on Sewage at Thompson Grove.

SUBJECT: THOMPSON GROVE WASTEWATER OVERFLOWS UPDATE

The purpose of this memo is to provide an update on the wastewater overflow mitigations in Thompson Grove. This includes a description of the problem, works completed to date on this issue, observed residual issues, and the next steps to resolve the wastewater overflows.

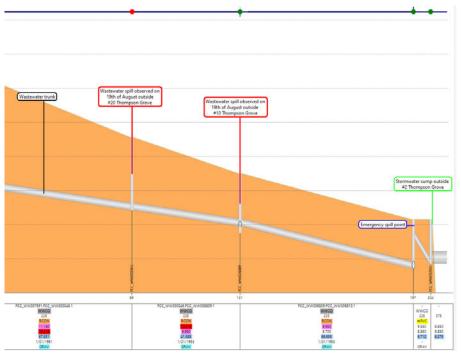
Figure 3 – Long section view wastewater trunk

A significant issue at this location is that the upstream pipeline above No.25 Thompson Grove, through Thompson Gully, is a larger pipe (300mm diameter) than downstream (225mm diameter). This will cause a capacity bottleneck until the pipe downstream of No.25 is upgraded to a larger diameter.

Figure 3 shows a cross-section of the pipe and the locations of the observed spills compared to the location and elevation of the constructed overflow.

c. Renewal planning. Due to the bottleneck in the pipe capacity, Thompson Grove has been identified as requiring a capacity upgrade to a 300mm diameter pipe. This is proposed to be completed as part of Eastern Porirua redevelopment work. This works has been approved by PCC and will be undertaken in conjunction with the Bothamley Park trunk sewer upgrade being undertaken by the Te Aranga Alliance and will be subject to their project timing.
