13 May 2024

### Request for information regarding the ruptured Porirua Pipe: LGOIMA IRO-634

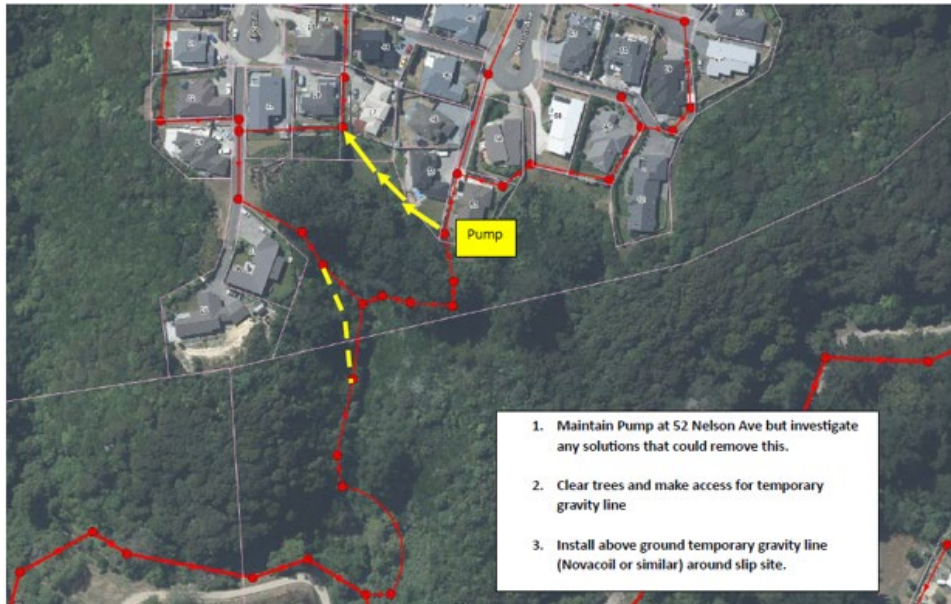
- In consultation with the Geotechnical Engineer, a solution temporary pipe bridge to reconnect the Nelson Avenue gravity main is still being worked through which will remove the need for the secondary pump.
- ETA for this is the end of next week.
- Geotechnical drilling and assessment of ground conditions to assess feasibility of this was completed last week with temporary design work being completed.

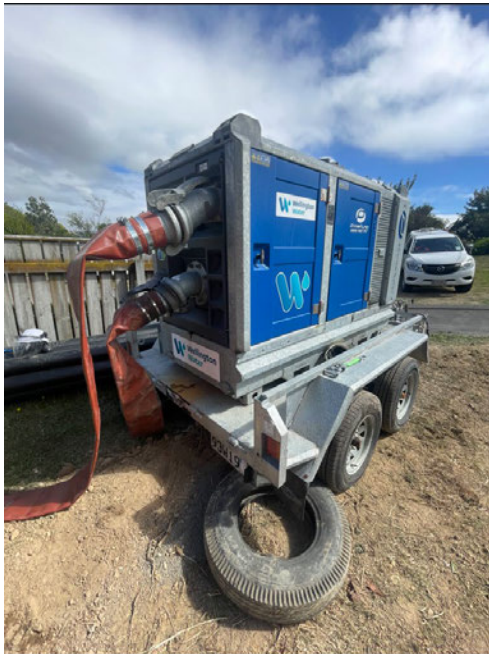
**Geotechnical Engineers (ABuild):**

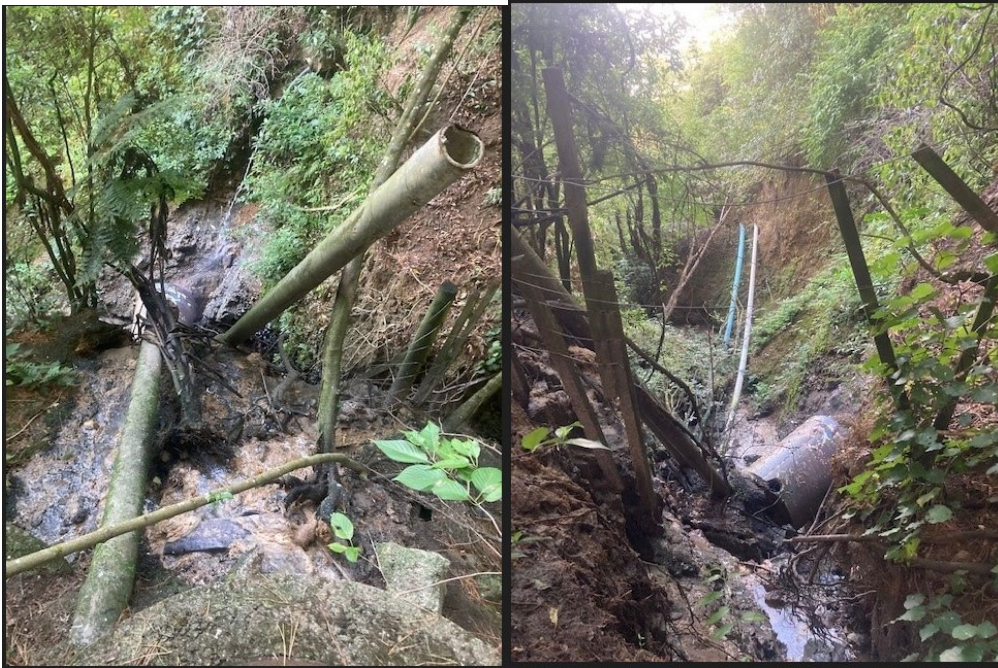
**Current Action Plan – agreed on by the Incident Management Team and being immediately implimented:**

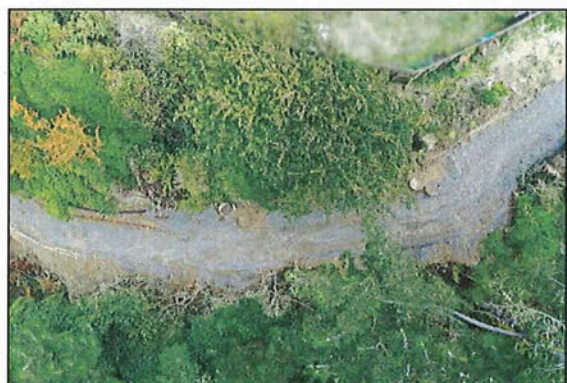
**Figure 3: Drone image showing cut proximity to No. 23, incl. existing manholes that would have been exposed prior to the emergency works cut.**

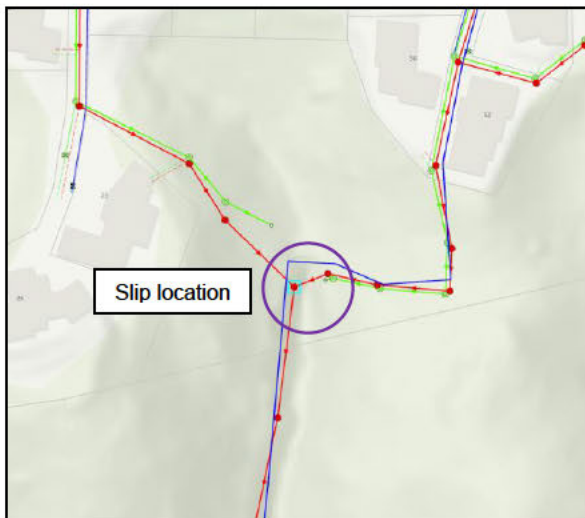
**Figure 1: Slip location**

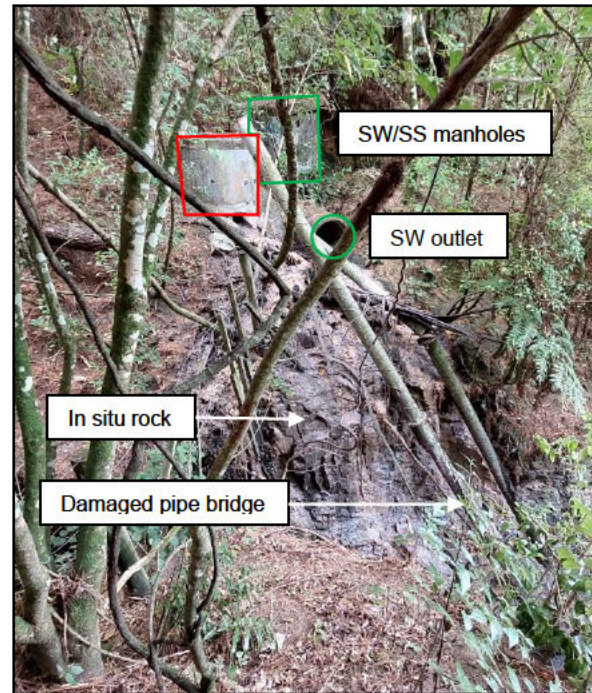
**Figure 2: True left SW and SS manholes and broken aerial pipe bridge**

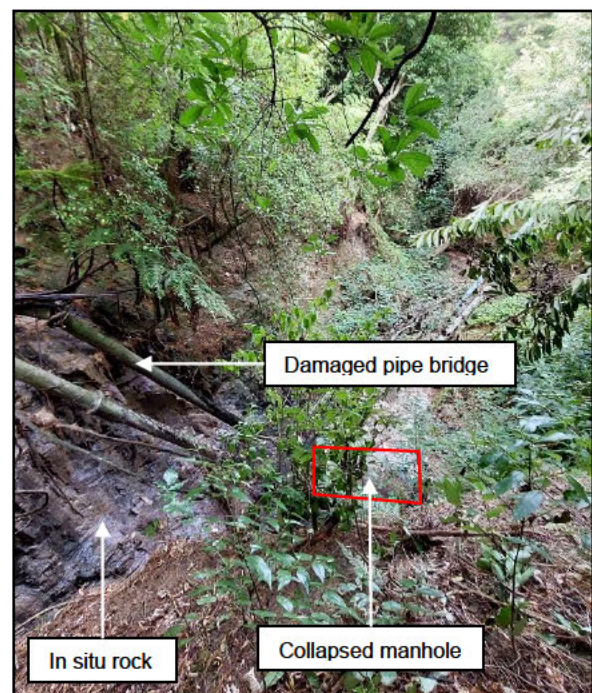
## Inferred Ground Conditions

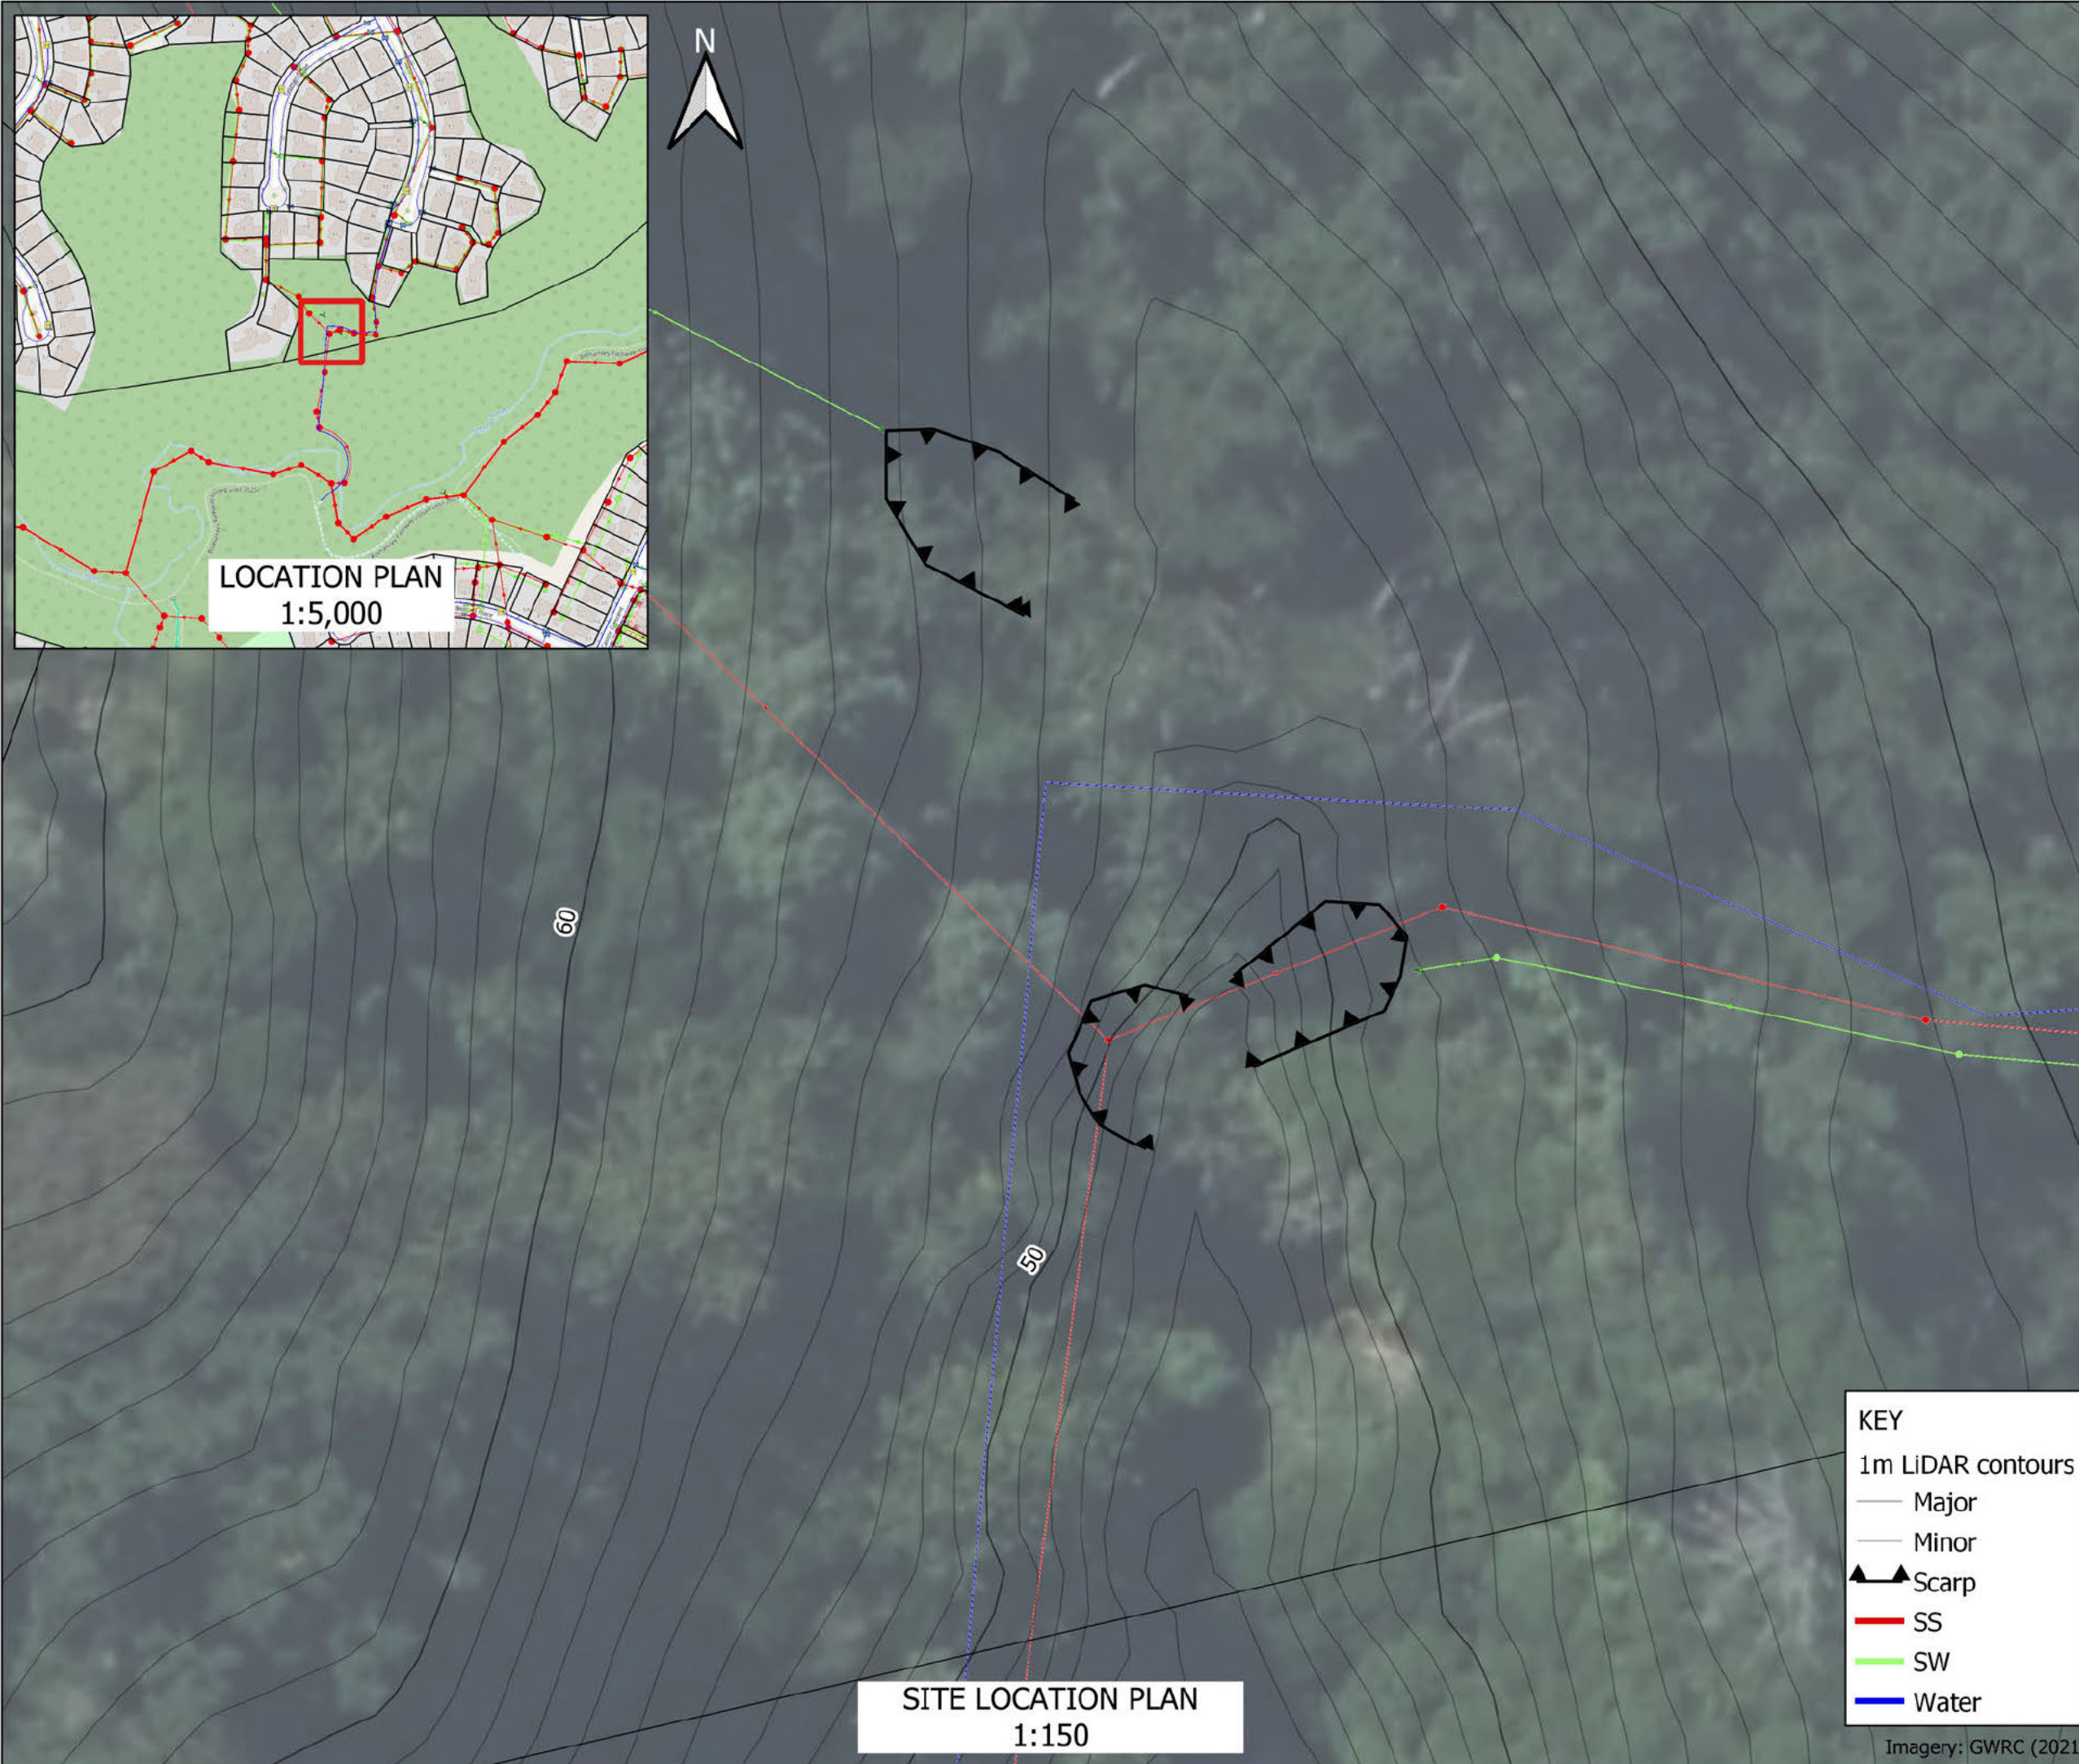
NOTES:  
1. DIMENSIONS AND LOCATIONS ARE APPROXIMATE ONLY.
