# **Martinborough Wastewater Treatment Plant Overflow Incident Investigation and Report: January 2020**

# Document Control

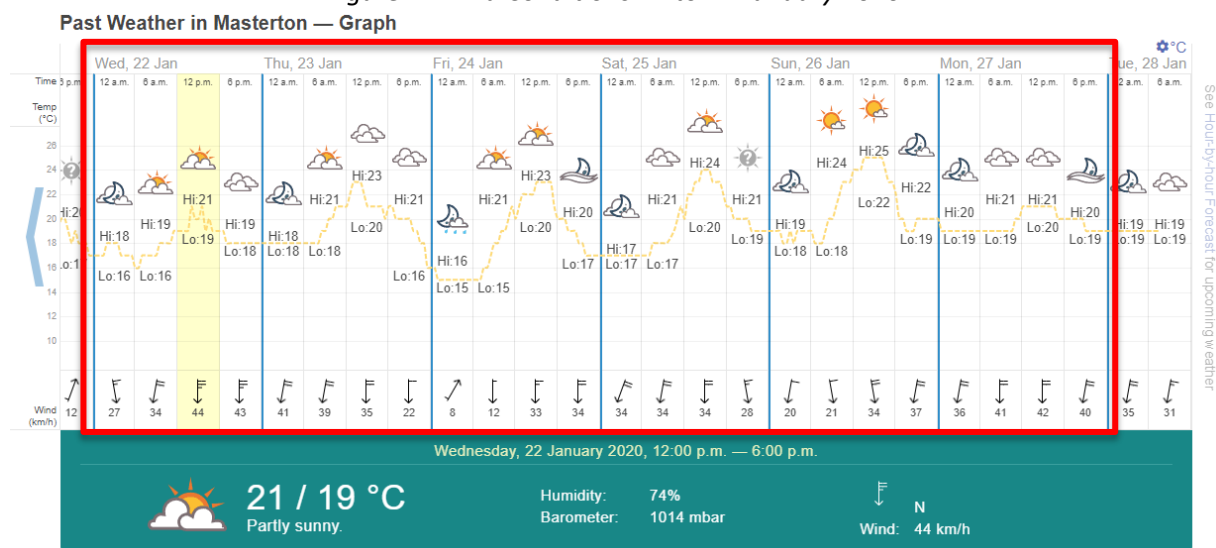
Figure 1: Wind Conditions 22 to 27 January 2020

Plant monitoring data indicates, the land irrigator stopped about 3:00am, during a high wind period. This meant that we were continuing to use the limited storage in the ponds. The irrigator is configured to only operate at a wind velocity below 12 km/hr to prevent treated wastewater from being carried off-site by the wind in accordance with consent conditions. Figure 1 (below) shows the wind conditions from an independent monitoring site in Masterton.

The irrigator cannot operate when the wind velocity is above 14 km/hr, which means wastewater must be stored on-site. This led to the already full storage ponds exceeding capacity and discharging to the river.

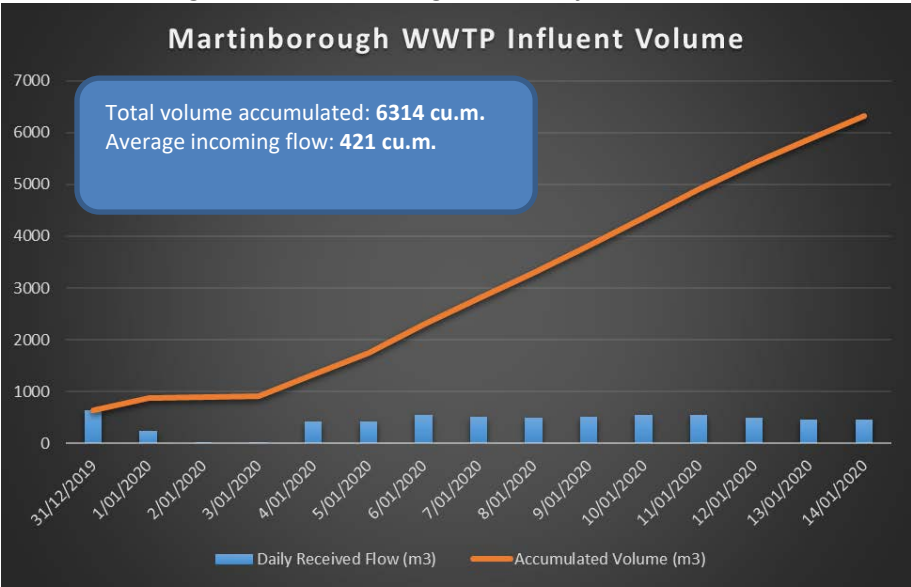
Figure 2: Martinborough WWTP Influent Volume

The accumulated incoming wastewater volume from December 31, 2019 to January 14, 2020 was 6314 cubic metres which is about 27% of the total capacity of the pond and exceeded the capacity of the available storage. The inability of the system to irrigate treated wastewater to land eventually led to an overflow from the maturation pond’s overflow pipe and over the pond’s bank. The graph for the inflow data is shown in Figure 2.

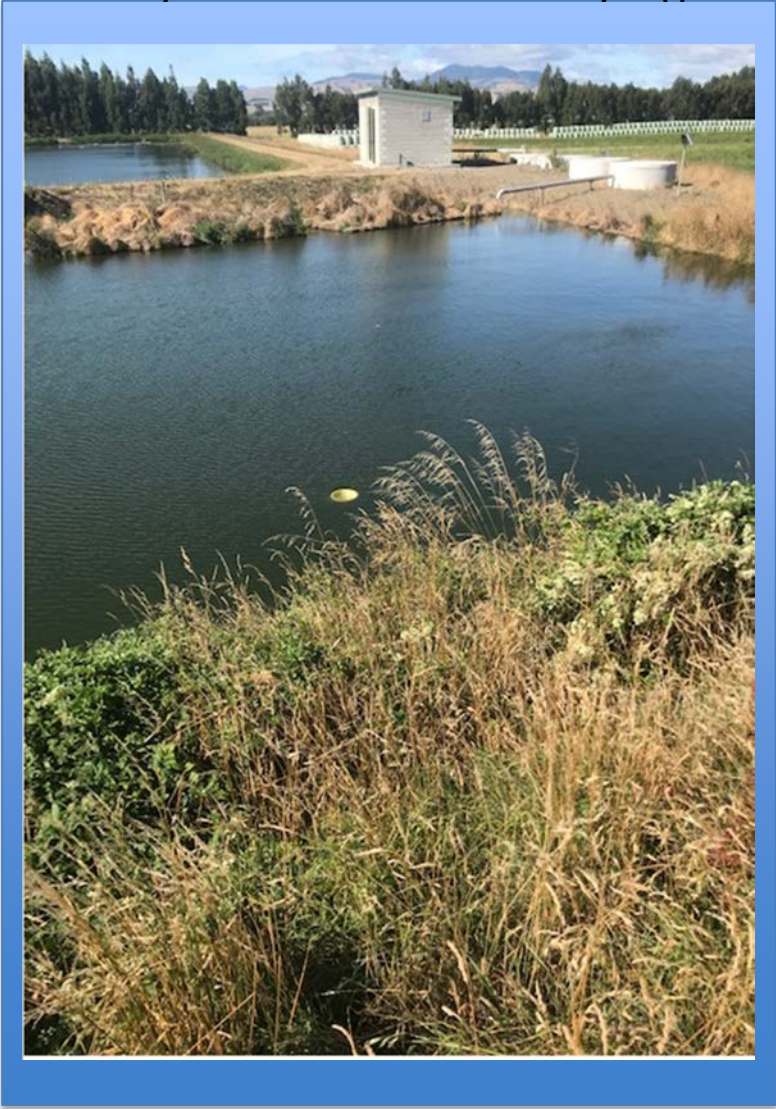
January 27 11:30 – Overflow had already stopped

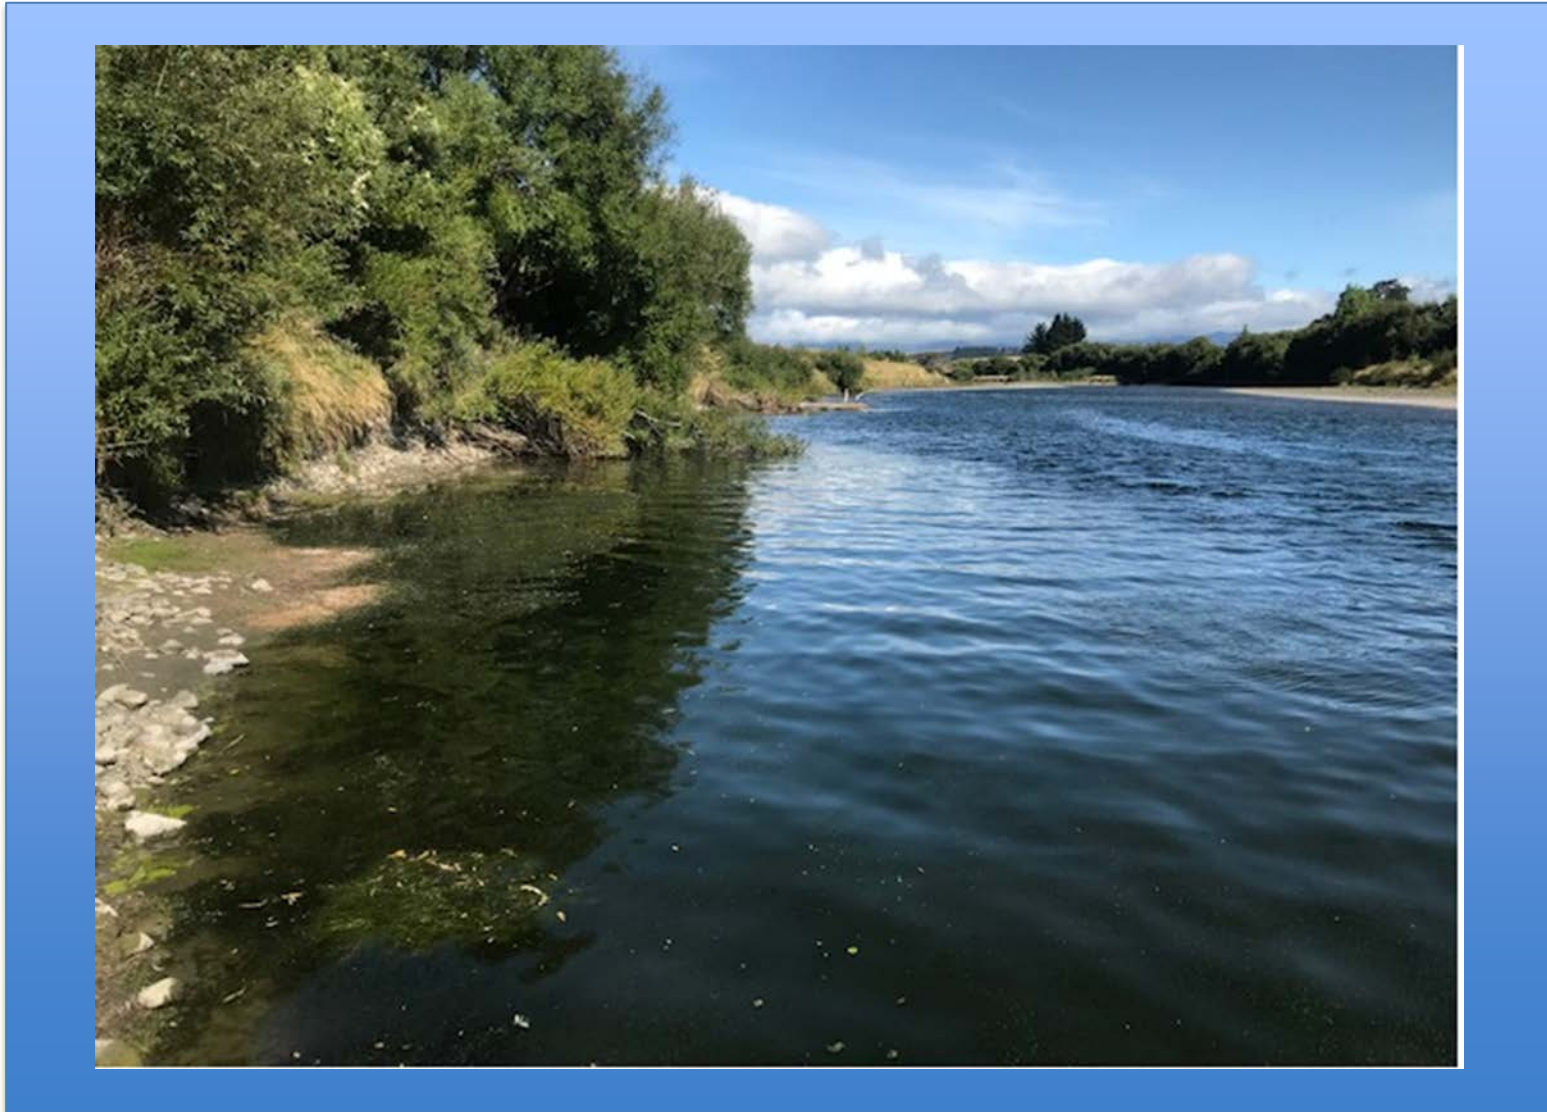
**Visual Status of the River within 30m from point of discharge**

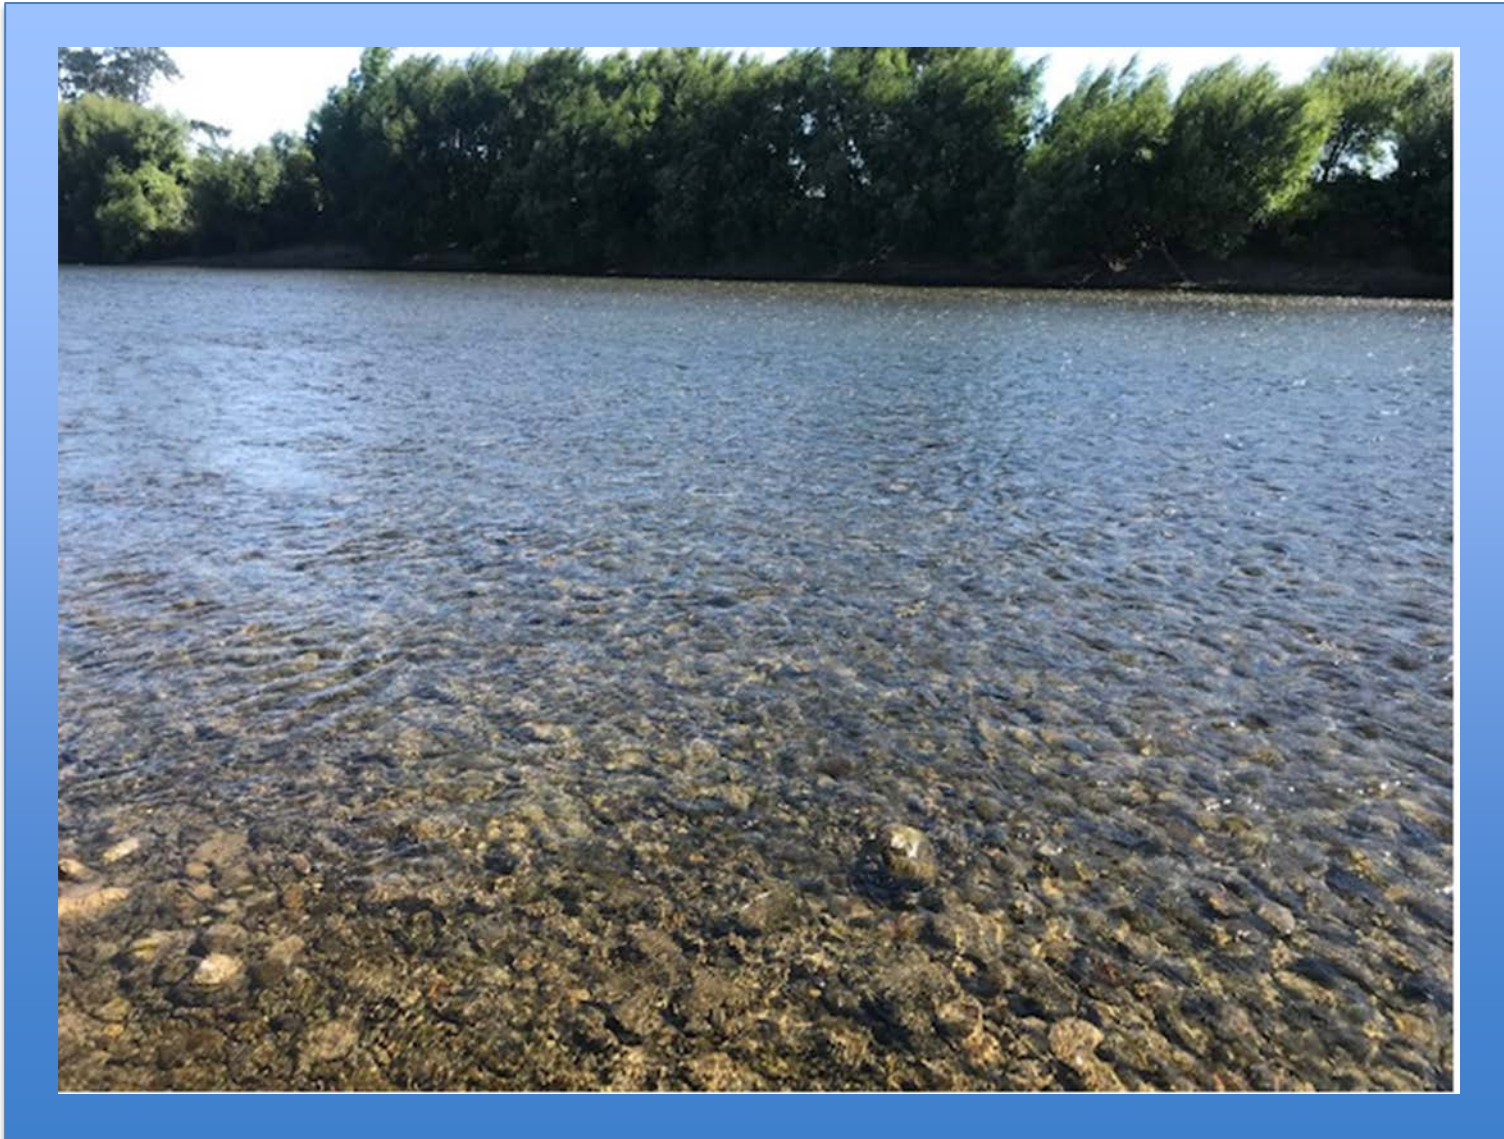
Visual Status of the River 30m downstream

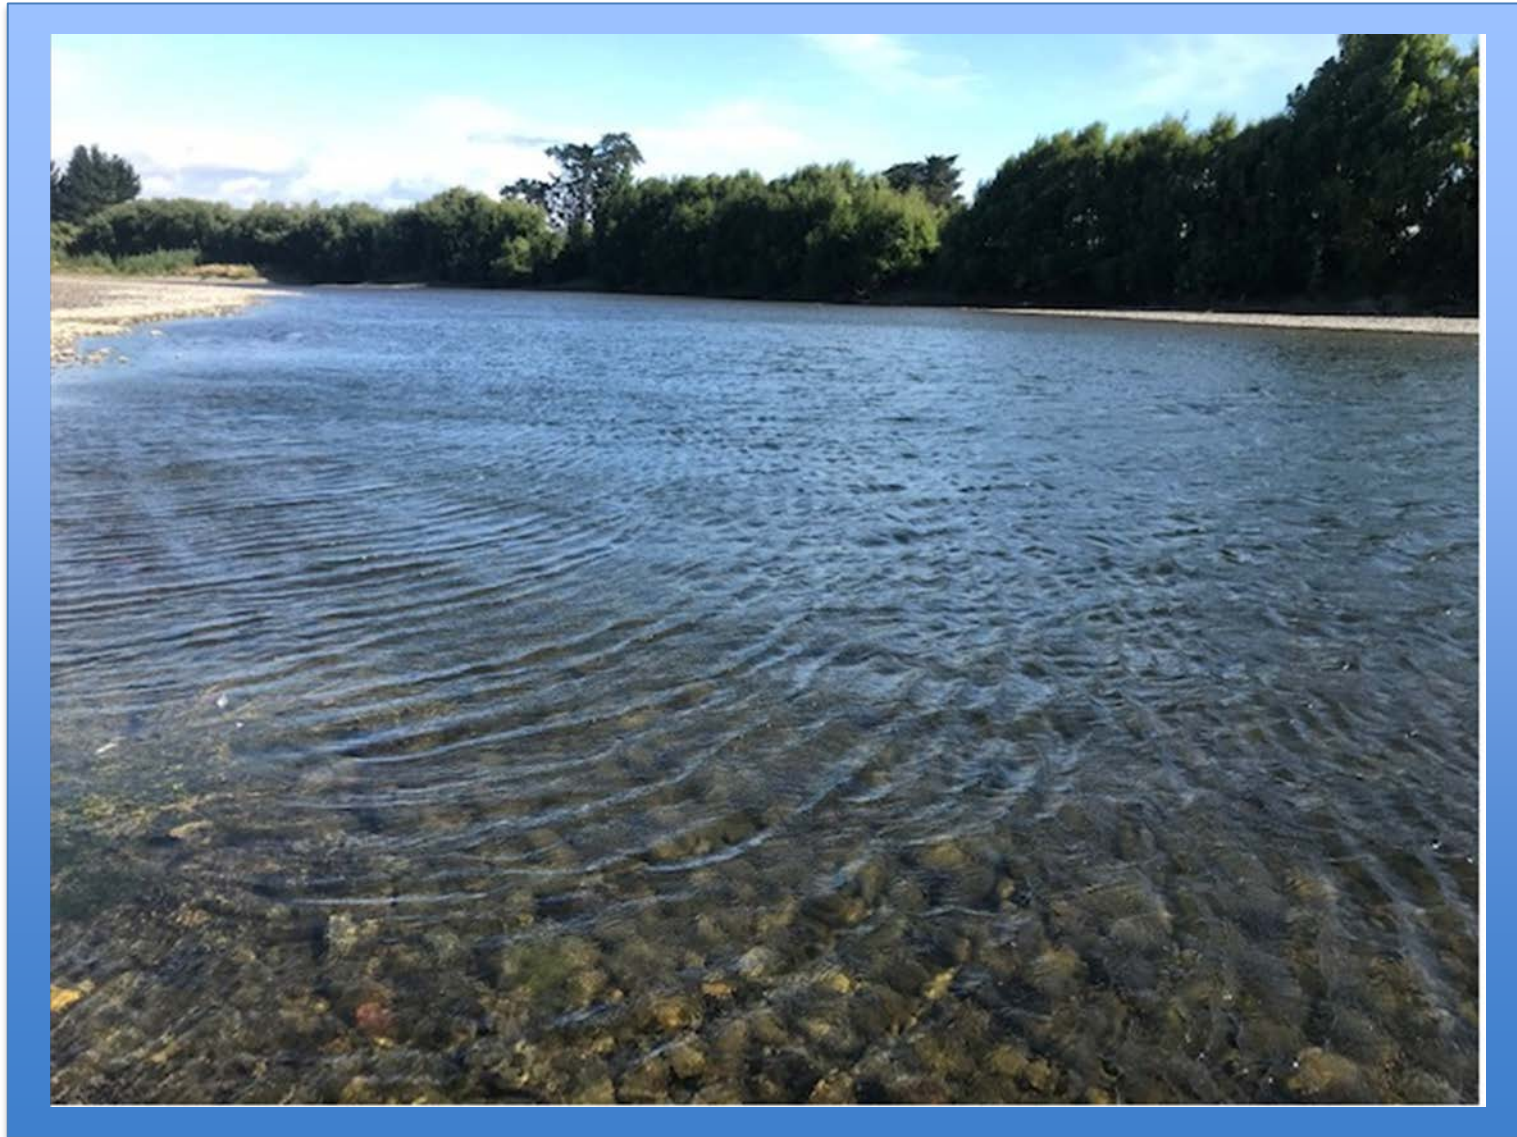
Visual Status of the River 30m downstream
