HUTT CITY COUNCIL INITIAL LANDSLIDE ASSESSMENT REPORT

Site Address	76 and 78 Howard Road, Point Howard, Lower Hutt
Site Coordinates	Latitude: -41.251093; Longitude: 174.909924
Date Assessed	14 March 2023
Report Date	31 March 2023
Assessed by	Lauren Foote
Reviewed by	Adam Smith

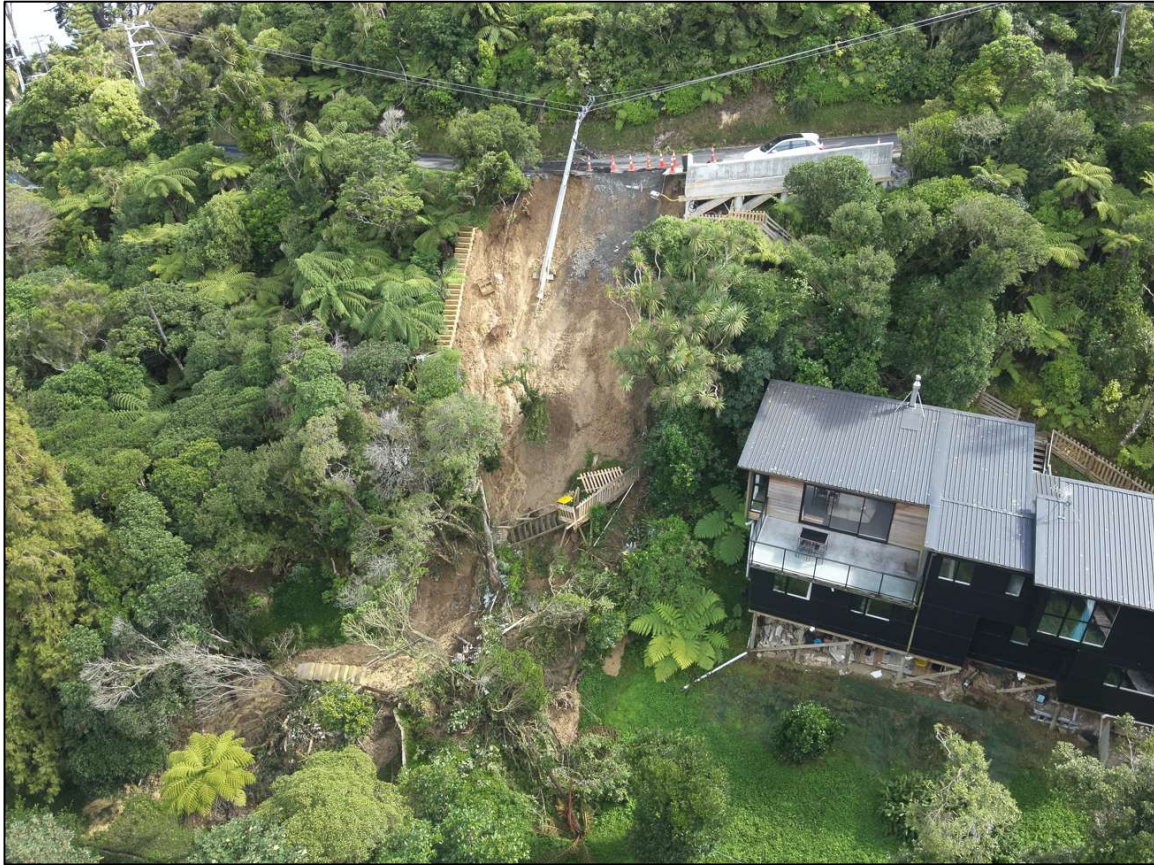
Photo 1: Aerial imagery of landslide provided by Fire and Emergency NZ

- The headscarp of the landslide extends for approximately 10 m along the edge of Howard Road above the properties at 76 and 78. The scarp is approximately 2 m high and formed at approximately 60° from horizontal.

- The failure mechanism appears to be shallow translational sliding of the surface fill and colluvium soils. It appears that the upper 1 m to 1.5 m of soil has been released downslope.

To decrease the risk of the above-mentioned events occurring we recommend that a bund (asphalt) is installed at the top of the slope to try to prevent surface runoff from the road onto the landslide face. ENGEO visited the site on 16 March 2023 and advised Wellington Water on the location where this should be installed.

We also recommend that survey monitoring of the roadway is undertaken to detect any future movement in either vertical or horizontal planes. This should comprise the placement of markers on the asphalt surface of the current road. ENGEO directed surveyors from Spencer Holmes to undertake the installation and baseline readings of these markers on 16 March 2023. Ongoing monitoring should be undertaken as follows:

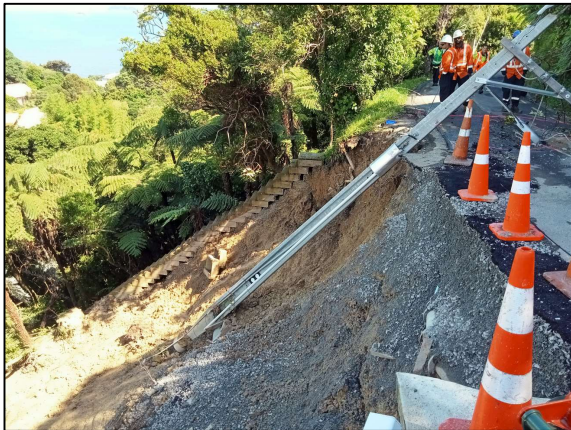
Photo 2: View of landslide facing to the southwest

- **Leaking Water Pipe** – Based on the reported water flow from the slope leading up to the landslide event, and the repairs that occurred in the day prior to the landslide, it appears that the water main had been leaking at a moderate to high rate and saturated the near surface soils.
- **Recent Rainfall** – The landslide event occurred on the day following a 22 mm rainfall event. While this is a notable rainfall event, it is not exceptionally high and therefore is unlikely to be the sole contributor to the landslide trigger.

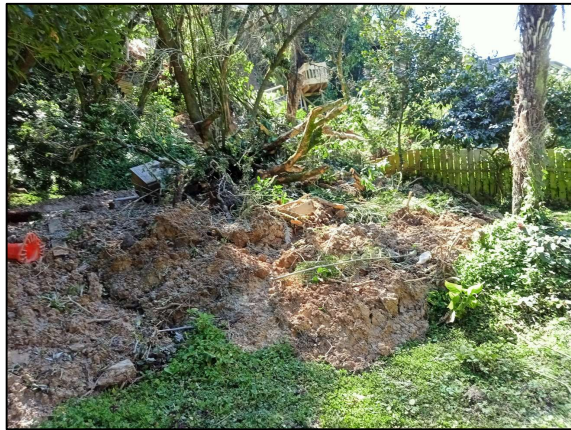
Photo3: Landslide debris deposited at toe of slope

- Debris associated with the landslide have runout to the base of the gully, at an elevation of approximately 20 m below the headscarp.
- Immediately to the northeast of the landslide is a pile supported, concrete car parking platform. From our review of historical aerial imagery, we can constrain the time of construction to between 17 March 2021 and 25 May 2022.
