**Official information request regarding Ngauranga wastewater pipe.**

### **TYERS RESERVE WASTEWATER INSPECTION & SCOPING OPERATIONAL WORK**

The purpose of this report is to provide a summary of the wastewater asset inspection in Tyers Reserve and proposed operational scope of work.

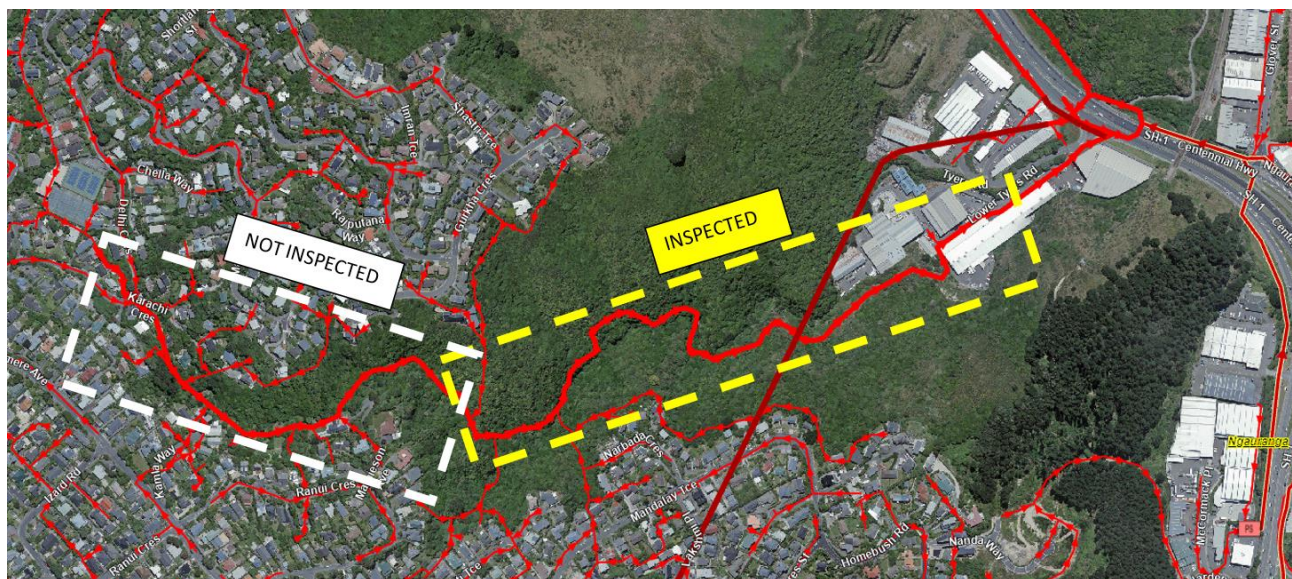
Wellington Water Customer Operations Group (COG) Customer Planning Engineer and Technical Advisor completed a walkover of Tyers Reserve Wastewater lines on Thursday 15<sup>th</sup> September starting from Lower Tyers Road and walking up Tyers Reserve and stream. Approximately 3 kilometres of the wastewater pipe and stream was visually inspected before suitable access prohibited any further safe inspection. A map of the inspected network is shown below.

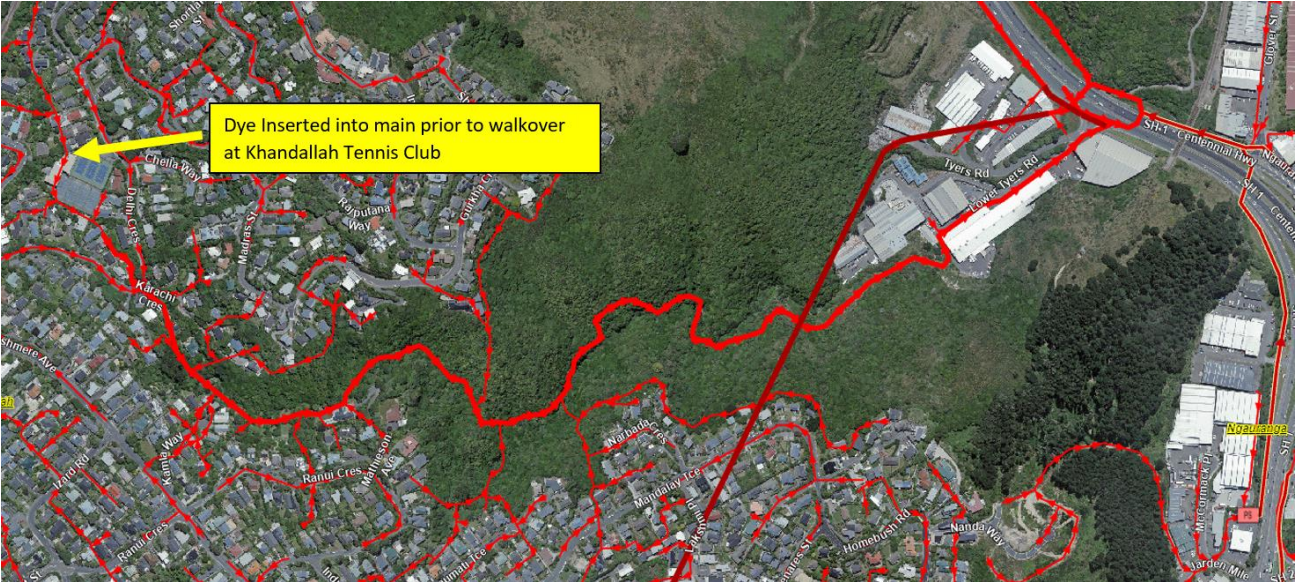
Prior to the site inspection walkover dye was introduced into the wastewater network using standard drainage dye, the purpose of this is that any leak in the wastewater pipe in close proximity to the stream would leak dye and would be identified through colouration of the stream. No dye was identified in the stream or leaking from wastewater pipe during the inspection. A map of where dye was introduced prior to the inspection is shown below.

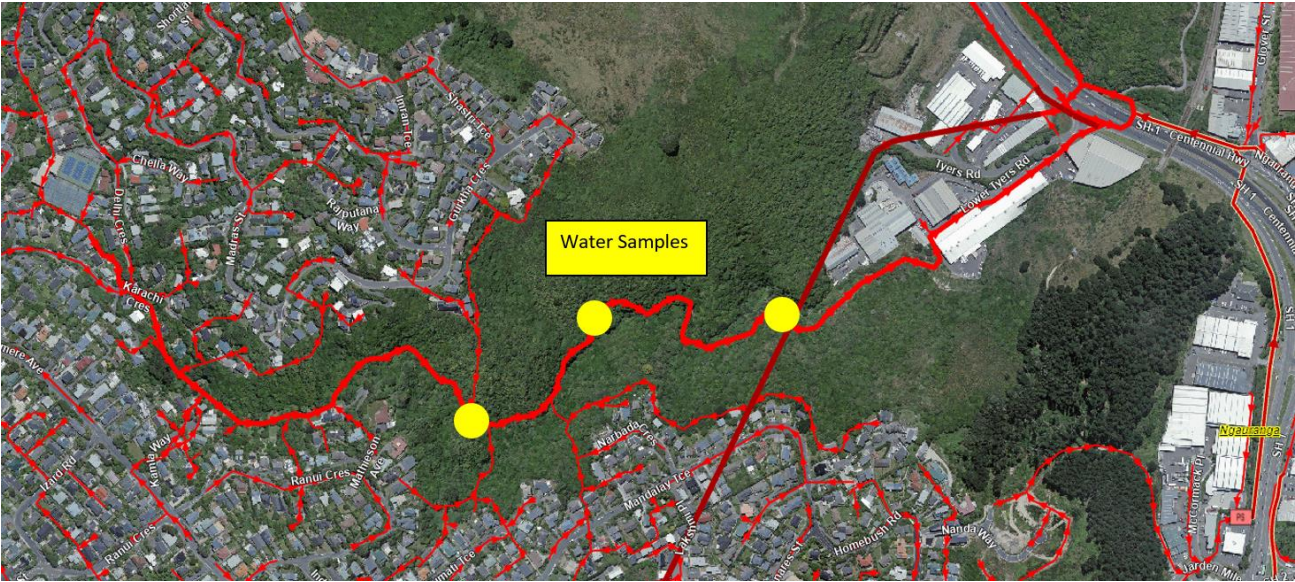
Water quality samples were taken in 3 different locations in the stream and these samples were analysed in a laboratory. A map of approximate locations where water quality samples were taken is shown below with the results shown further in this report.

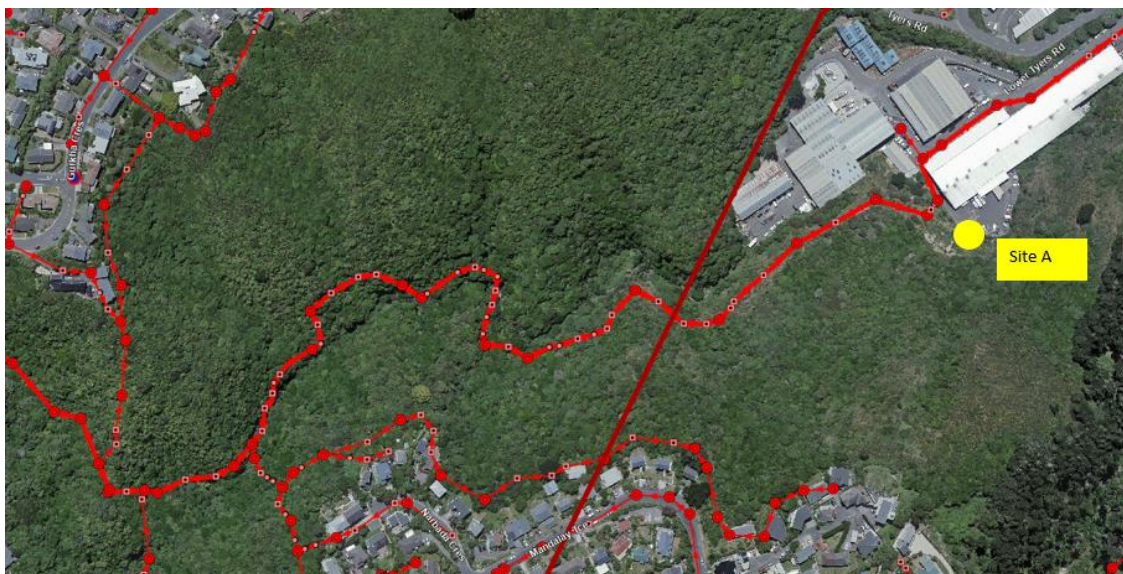
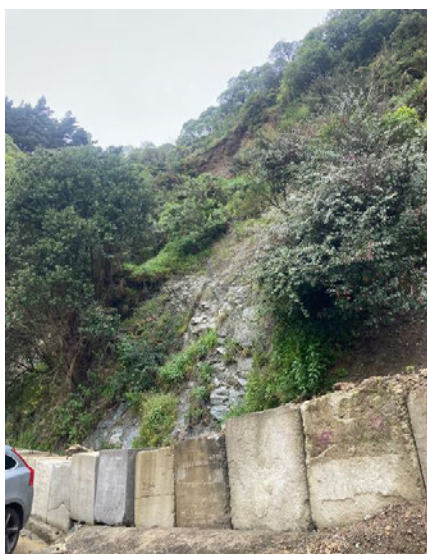
#### 3.1 Site A

Site A is located behind National Storage facility on Lower Tyers Road, the customer has noticed water running through the concrete blocks which have been installed to retain a historic slip above the carpark. A seepage sample was collected from the water source seeping through the concrete block. Water is visibly running off slip faces above the slip. The wastewater main is located a distance away to the east of the water source.

The seepage sample results confirm that the water source is not wastewater.

No work is recommended at Site A.

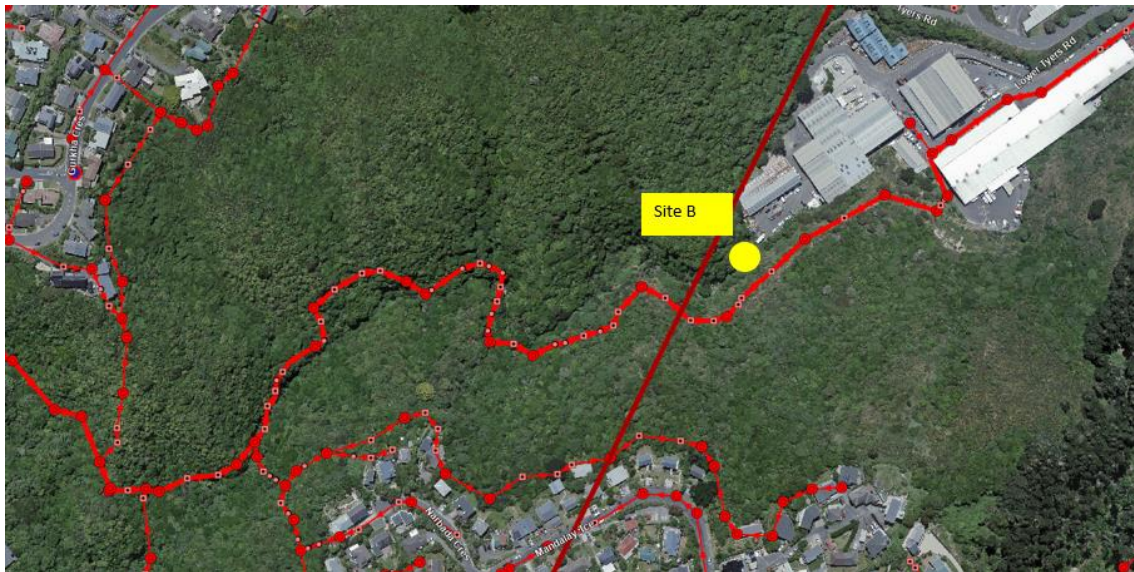
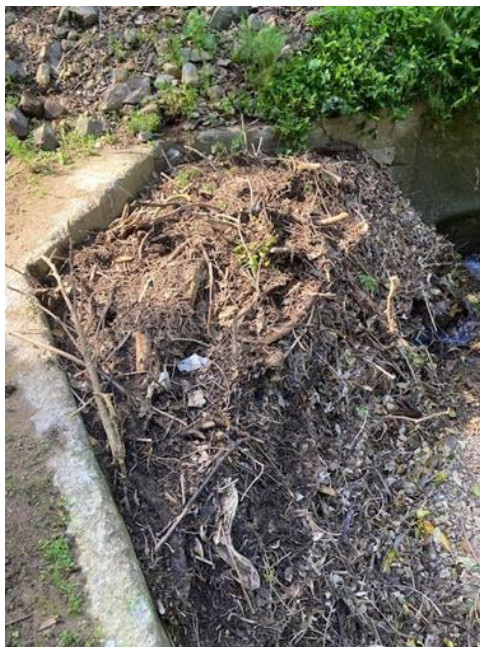
### 3.2 Site B

The stormwater intake WCC\_SW017938 is currently blocked by debris.

A water quality sample was taken at the site confirming no trace of wastewater in the stream

No dye was identified or witnessed at Site B

It is recommended that the inlet structure is cleared and maintained as soon as possible.

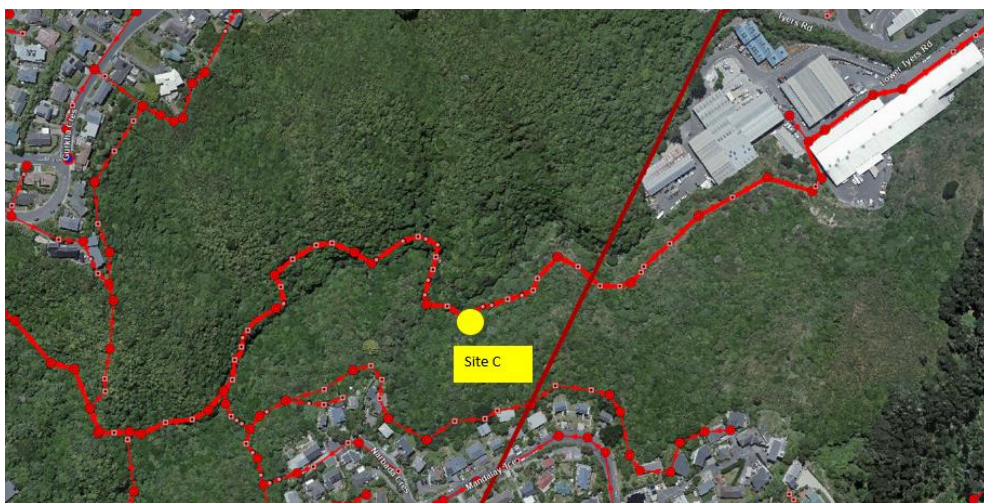
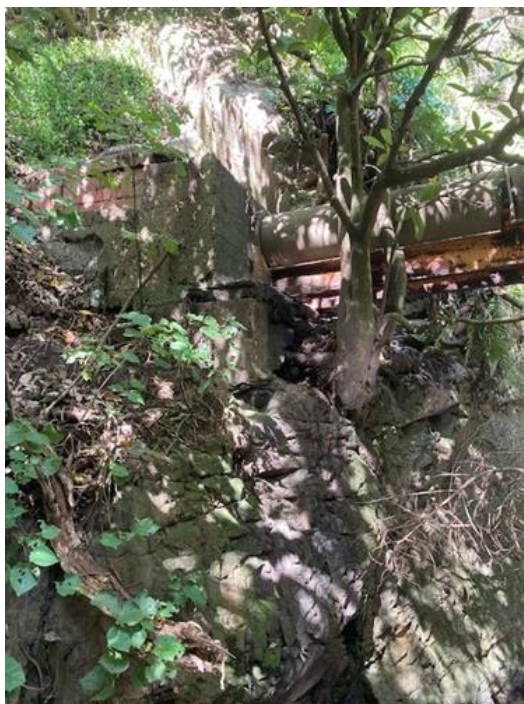
### 3.3 Site C

Wastewater manhole WCC\_WW034944 at the first downstream bridge crossing is seeping from joint. It is recommended that the manhole is rehabilitated using Mastermix rapid repair and armour or similar product.

Foot access to the site is reasonable in all conditions however access to the manhole could be improved to carry out the specific works.

No dye was identified or witnessed at Site C

It is recommended that the manhole is rehabilitated using epoxy resin.

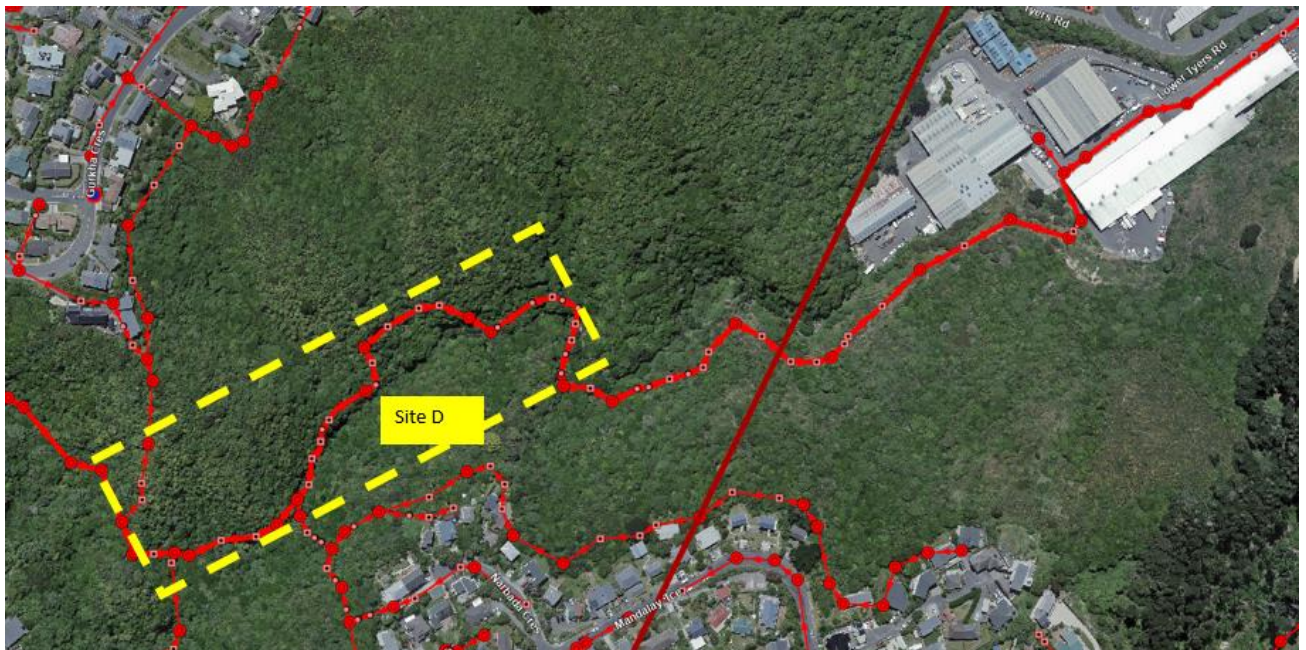
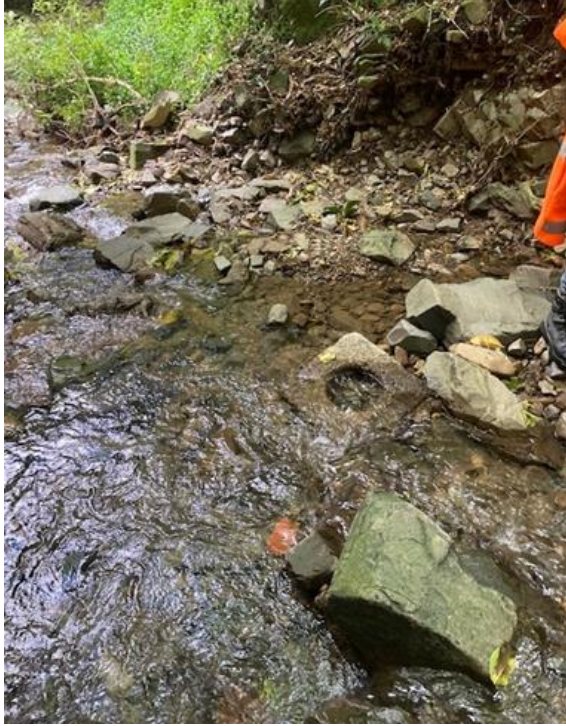
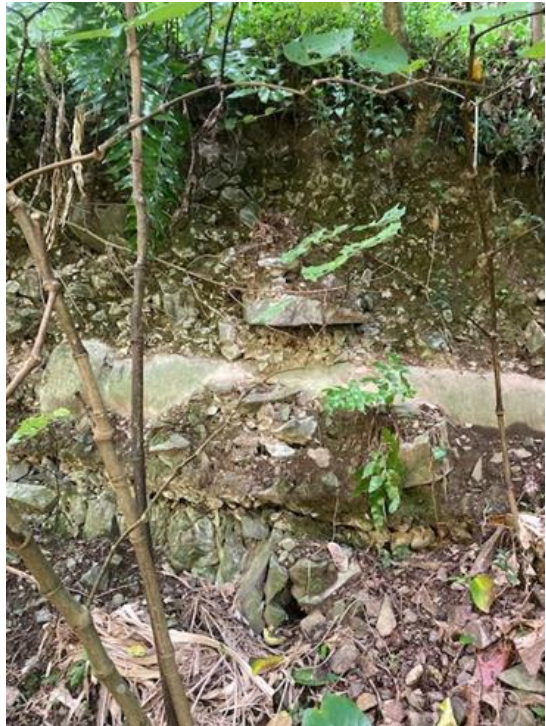
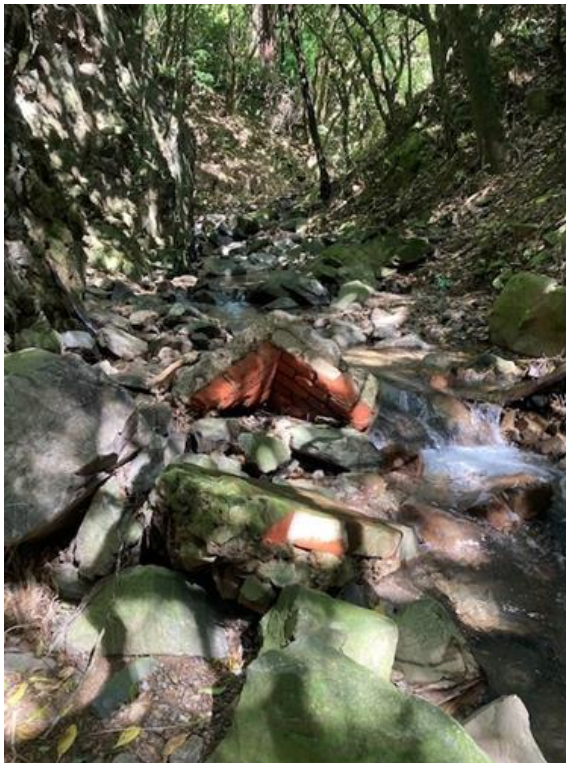
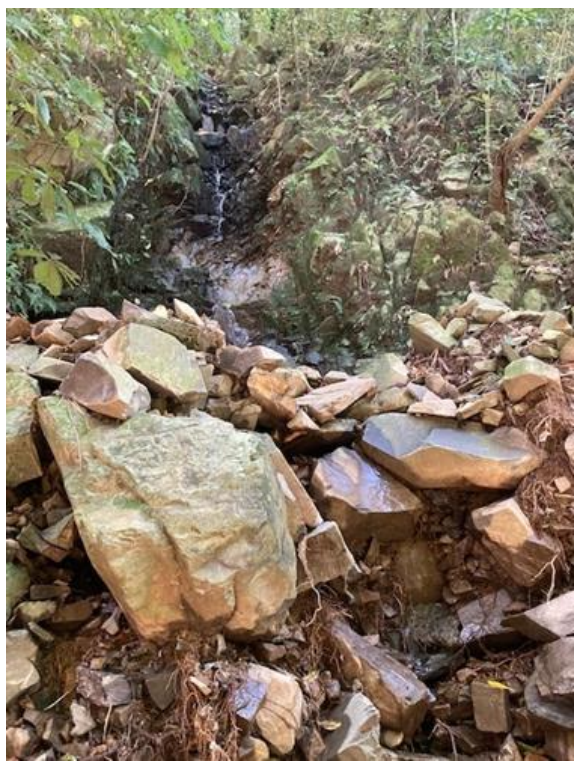
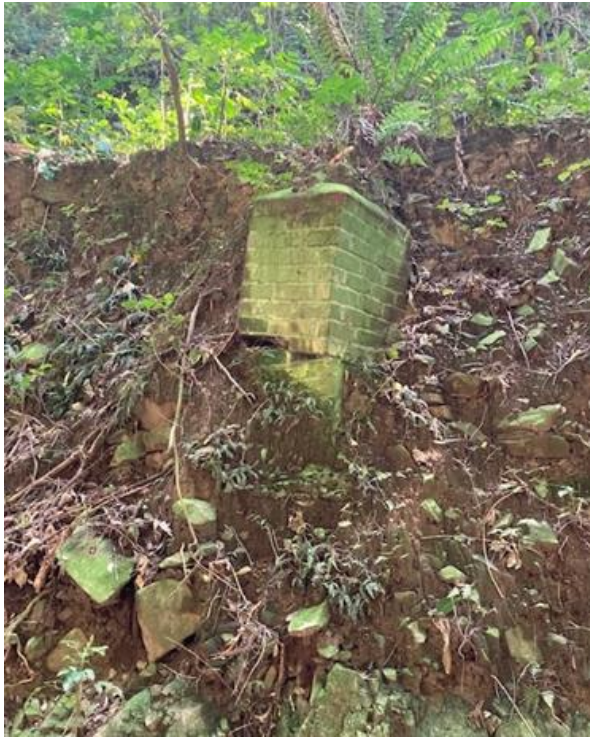
### 3.2 Site D – remaining alignment inspected upstream of Site C

The wastewater pipe is exposed in places resulting from movement or erosion of the stream or banks upstream of Site C. No wastewater or dye was visually inspected however wastewater odour smell can be detected in locations along the alignment.

Large rocks have fallen on the pipeline in location of a tributary stream coming into Tyers Stream.

Branch wastewater lines off the trunk main have been replaced previously due to washouts, structures from these washouts are still visible within the stream including manhole and inspections which have washed downstream.

Foot access upstream of Site C is poor, the stream alignment has altered since the wastewater pipeline was constructed. It would not be possible for any equipment or gear to be mobilised of Site C without significant access tracks being formed.

No dye was identified or witnessed at Site D.

A water quality sample was taken at the site confirming no trace of wastewater in the stream.

No immediate operational work is recommended at Site D or upstream of Site C. It is recommended that a re inspection and re sampling is completed in December 2022 for comparison and monitoring.
