**Official information request for the October 2022 Paper regarding the Tyres Stream leak.**

## MEMO

### **TYERS RESERVE WASTEWATER INSPECTION & SCOPING OPERATIONAL WORK**

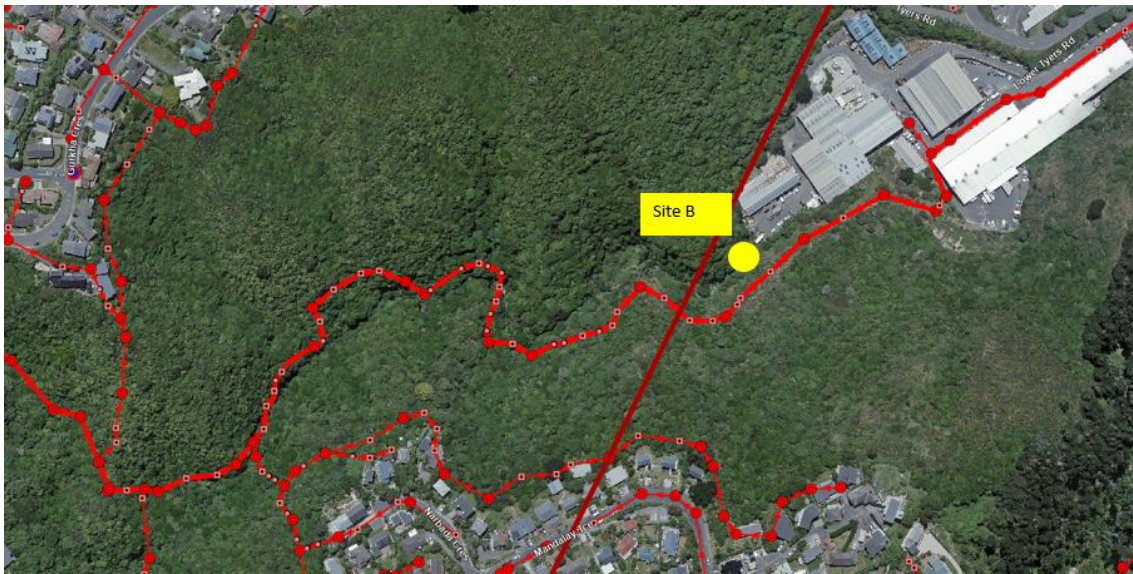
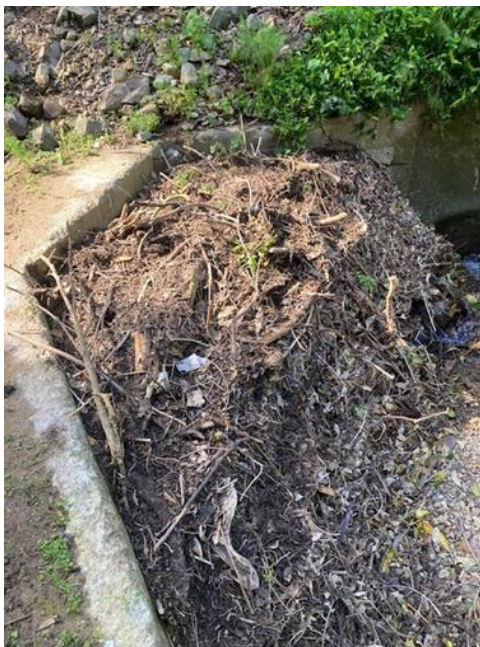
### 3.2 Site B

The stormwater intake WCC\_SW017938 is currently blocked by debris.

A water quality sample was taken at the site confirming no trace of wastewater in the stream

No dye was identified or witnessed at Site B

It is recommended that the inlet structure is cleared and maintained as soon as possible.

- Clear stormwater inlet structure WCC\_SW017938
- Repair Wastewater Manhole WCC\_WW034944 including provisions of safe foot access to this manhole.
- Re sample and site walkover stream locations in December 2022 for comparison of stream quality.

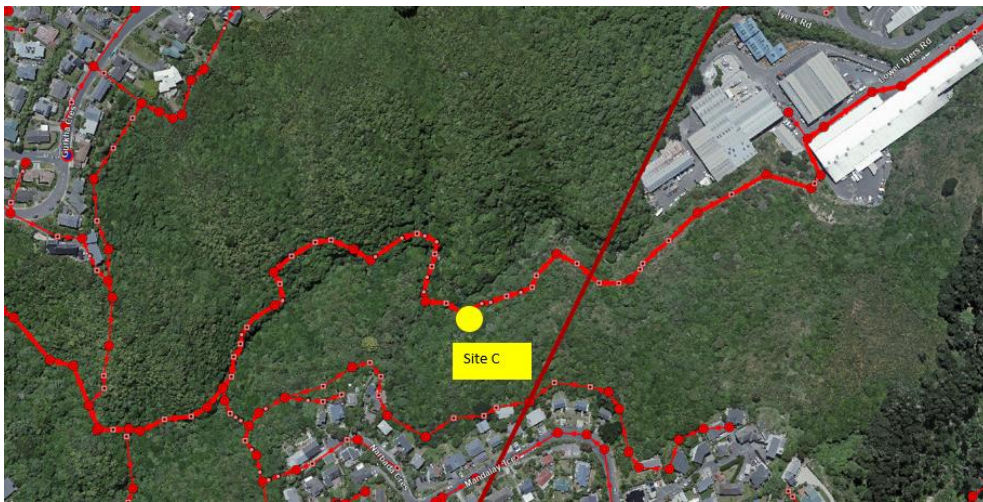
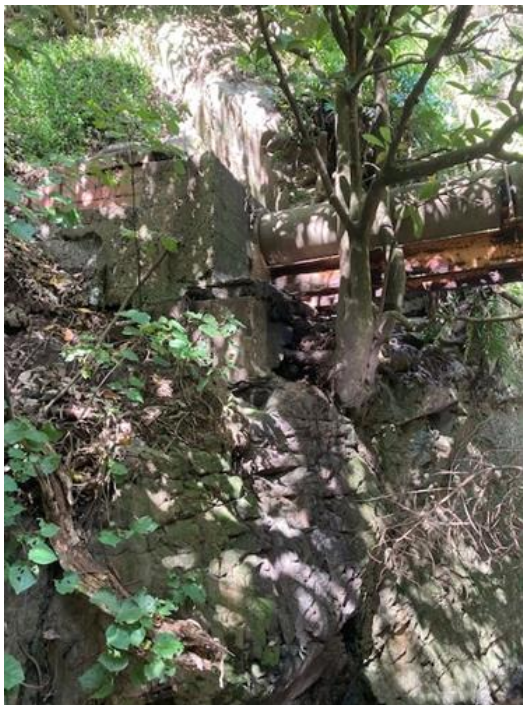
### 3.3 Site C

Wastewater manhole WCC\_WW034944 at the first downstream bridge crossing is seeping from joint. It is recommended that the manhole is rehabilitated using Mastermix rapid repair and armour or similar product.

Foot access to the site is reasonable in all conditions however access to the manhole could be improved to carry out the specific works.

No dye was identified or witnessed at Site C

It is recommended that the manhole is rehabilitated using epoxy resin.

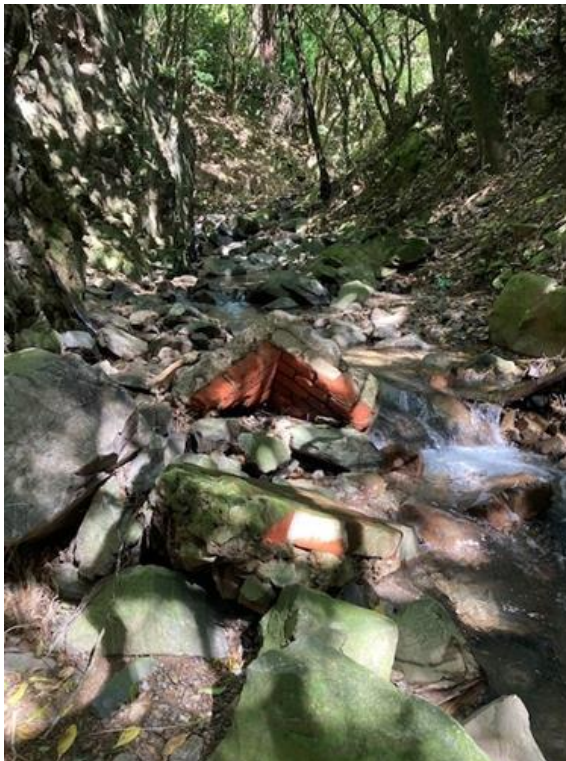
### 3.2 Site D – remaining alignment inspected upstream of Site C

The wastewater pipe is exposed in places resulting from movement or erosion of the stream or banks upstream of Site C. No wastewater or dye was visually inspected however wastewater odour smell can be detected in locations along the alignment.

Large rocks have fallen on the pipeline in location of a tributary stream coming into Tyers Stream.

Branch wastewater lines off the trunk main have been replaced previously due to washouts, structures from these washouts are still visible within the stream including manhole and inspections which have washed downstream.

Foot access upstream of Site C is poor, the stream alignment has altered since the wastewater pipeline was constructed. It would not be possible for any equipment or gear to be mobilised of Site C without significant access tracks being formed.

No dye was identified or witnessed at Site D.

A water quality sample was taken at the site confirming no trace of wastewater in the stream.

No immediate operational work is recommended at Site D or upstream of Site C. It is recommended that a re inspection and re sampling is completed in December 2022 for comparison and monitoring.

- Complete immediate operational scope of work as outlined in 4. Proposed operational scope of work.
- Reinspect the wastewater pipeline and complete sampling for comparison December 2022.
- The wastewater pipeline is added to the Wellington Water operational risk register with high risk rating.
- The wastewater pipeline is highlighted to Service planning in the event of failure it is unlikely that the pipeline will be able to be repaired, reconstructed or rehabilitated in the existing location due to safe access.
