Wellington Water Stage Two Global Stormwater Discharge Consent

Assessment of Effects on the Environment

June 2023

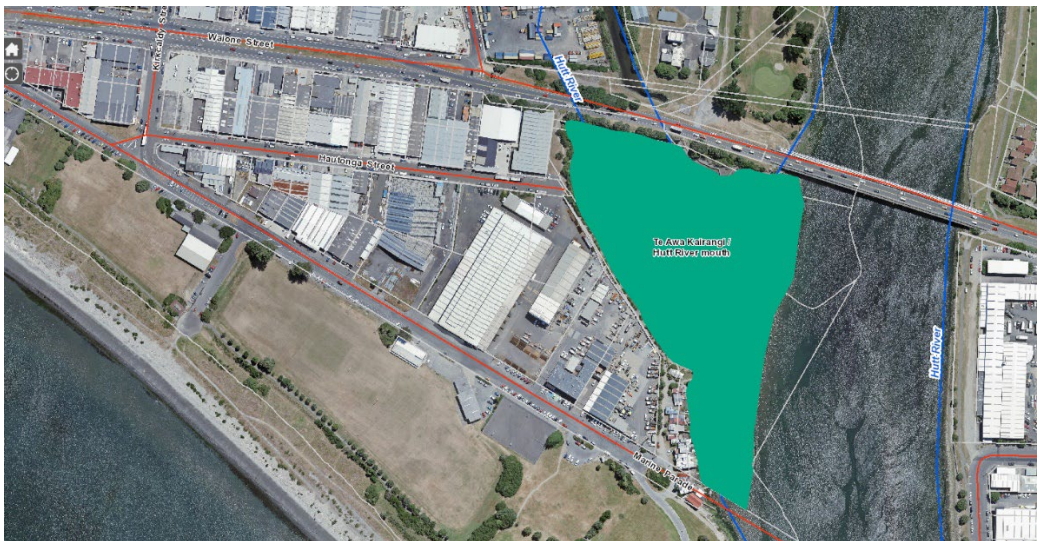
Wetland	NRP Schedule	Assessment
Te Awa Kairangi/ Hutt River mouth	F3

<p>Stormwater from the Hautonga Street commercial/light industrial area discharges directly to the Te Awa Kairangi/ Hutt River mouth wetlands. Robertson and Stevens (2017), reporting on sediment quality monitoring in the Hutt Estuary during 2017, found that heavy metals Sb, Cd, Ce, Cu, Hg, Pb, Zn and As were below ANZECC (2000) ISQG-Low trigger values and therefore posed no significant toxicity risk to aquatic life. One of the two monitoring sites was located immediately downstream of the Waione Street</p>

<p>Bridge, at the edge of the Te Awa Kairangi Wetland. The conditions were described as moderate-high muddiness, moderate sediment oxygenation, low-moderate organic carbon and nutrient concentrations, but with intermittent eutrophication symptoms. It is noted that the monitoring undertaken to date has not been specifically focused on the effects of local stormwater discharges from the adjacent commercial/light industrial area and that the contribution of local stormwater discharges to the current state of the estuary is not known. There, is nevertheless, no indication of any stormwater related impacts.</p> <p>The level of adverse effects from urban stormwater discharge is assessed as low.</p>
Duck Creek Saltmarsh	F3

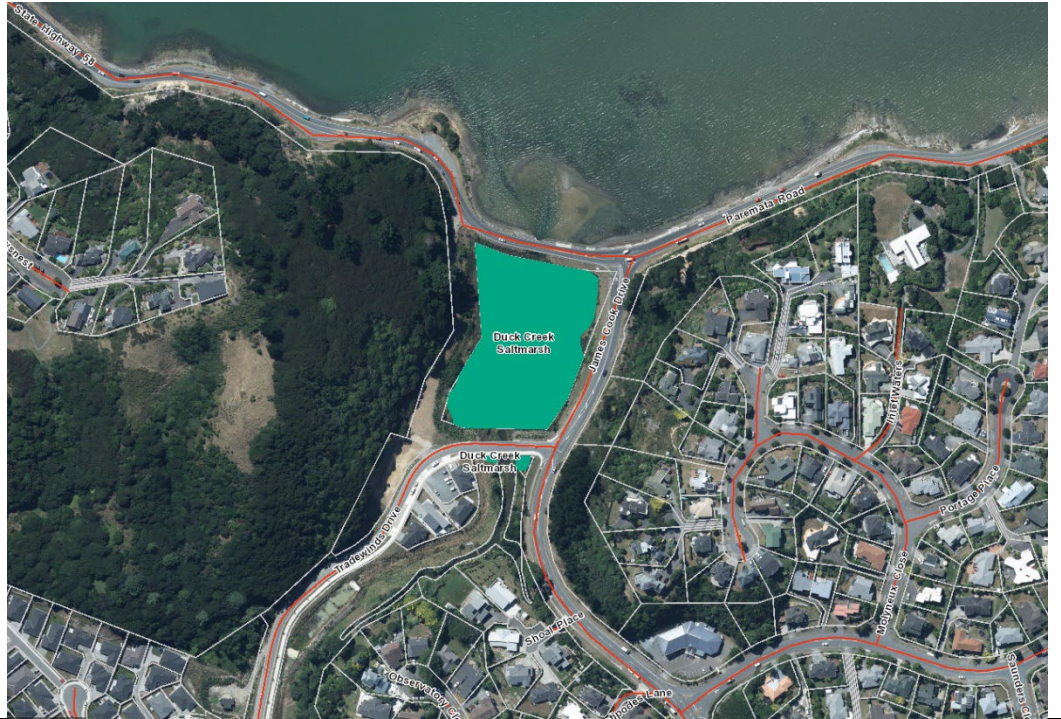
<p>Stormwater from residential areas in Whitby immediately to the east of James Cook Drive discharges directly to the Duck Creek Saltmarsh while stormwater from much of the upstream urban area of the Duck catchment (~3km²) discharges into Duck Creek where it mixes with stream water and then flows down into Pauatahanui Inlet via the saltmarsh. Approximately 39% of the Duck catchment area has urban land-use, nearly all of which is residential housing. As described in Section 4.18.8, there were no ANZG (2018) guideline exceedances of any of the metal or metalloids in sediments at the three sites within Pauatahanui Arm of Porirua Harbour. However, no sediment quality data is available for the Duck Creek Saltmarsh.</p> <p>The level of adverse effect from the discharge of urban stormwater to Duck Creek Saltmarsh is unknown but based on catchment characteristics is likely to be in the range from low to moderate.</p>

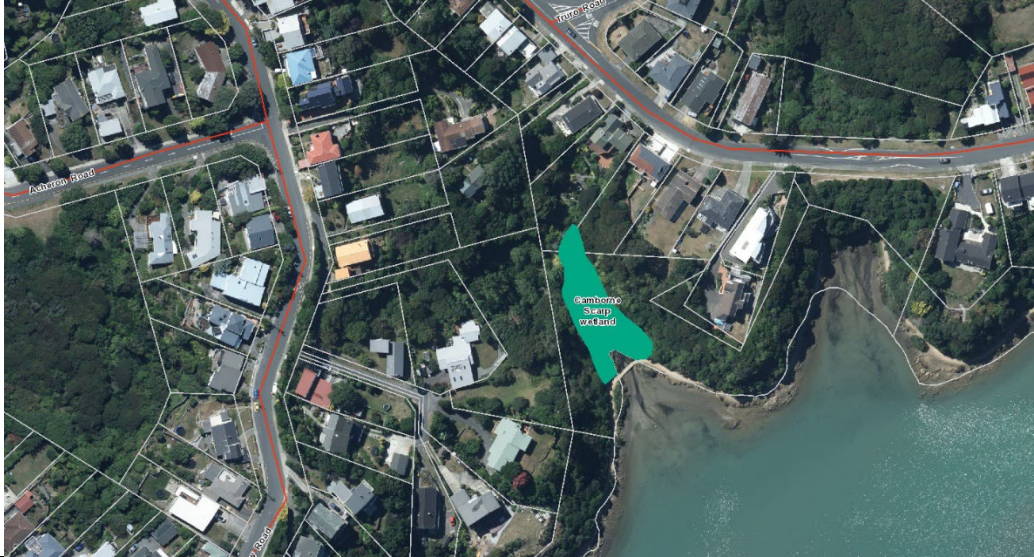
<p>Cambourne Scarp Wetland</p>	<p>F3</p>

<p>Stormwater from a small urban area of Truro Road and Pernryn Drive discharges into the Cambourne Scarp Wetland. This moderate density residential area has low traffic volumes and is not expected to cause stormwater related impacts within the wetlands.</p> <p>The level of adverse effect from the discharge of urban stormwater is assessed as low.</p>
<p>Te Awarua o Porirua Harbour (Onepoto Arm) – Tidal Flats</p>	<p>F3</p>	<p>Stormwater from most of the Porirua catchment discharges into the Onepoto Arm of Te Awarua o Porirua Harbour with potential impacts on the Tidal Flats. As described in Section 4.19.9, marine sediments at the south end of the Onepoto Arm currently exceed the ARC amber guideline concentration for copper, lead and zinc but no exceedance of ANZG (2018) default guideline values has been recorded. Exceedance of the ARC amber guideline provide early warning that contaminants are approaching levels that may be ecologically harmful. The available information suggests that the NRP O19 Objective is not currently met for macroalgae, invertebrates or mahinga ka, and that the discharge of stormwater from the Porirua catchment contributes to the poor ecological health of the Onepoto Arm.</p> <p>The level of adverse effect from the discharge of urban stormwater is assessed as moderate to high.</p>

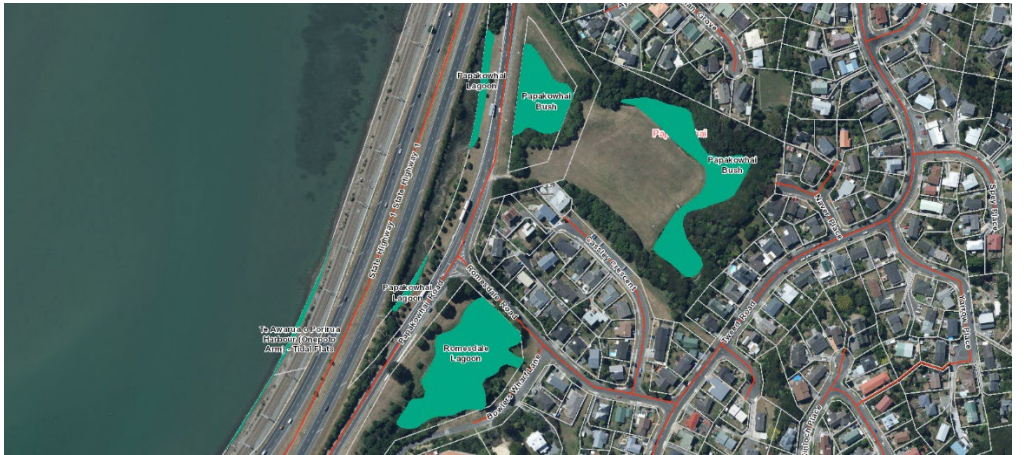
<p>Romesdale Lagoon, Papakowhai Bush, Papakowhai Lagoon</p>	<p>F3</p>

<p>Stormwater from a small area of urban Papakowhai discharges into Romesdale Lagoon, Papakowhai Bush, Papakowhai Lagoon. This moderate density residential area has low traffic volumes and in not expected to cause stormwater related impacts within the wetlands.</p> <p>The level of adverse effect from the discharge of urban stormwater is assessed as low.</p>

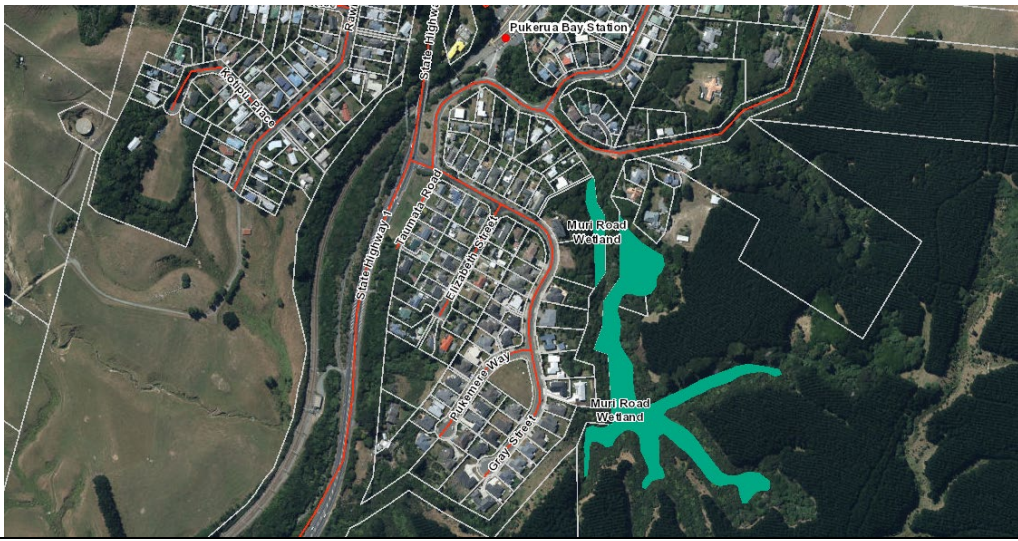
Muri Road Wetlands	F3

<p data-bbox="478 750 1532 828">Stormwater from a small urban area of around Gray Street in Pukerua Bay discharges into the Muri Road wetlands. This moderate density residential area has low traffic volumes and is not expected to cause stormwater related impacts within the wetland.</p> <p data-bbox="478 840 1532 862">The level of adverse effect from the discharge of urban stormwater is assessed as low.</p>
--------------------	----	--
