Seaview Wastewater Treatment Plant and HCC/UHCC Trunk Main

Annual Resource Consents Report 2019/2020

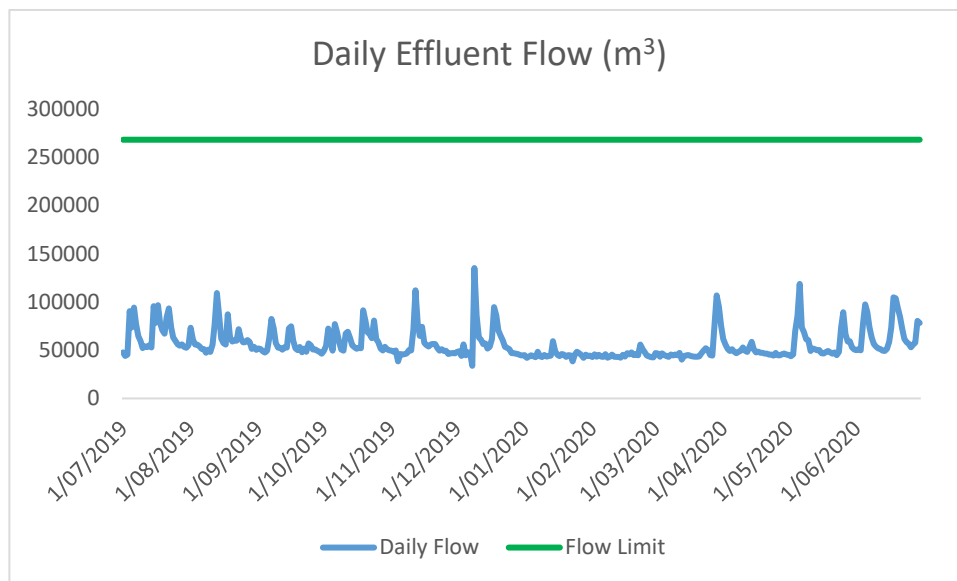
Chart 1: Effluent Flow Summary

Below is a summary of the effluent flow for FY2019/2020. The flows are well below the consent limit of 268,000 cubic meters/day.

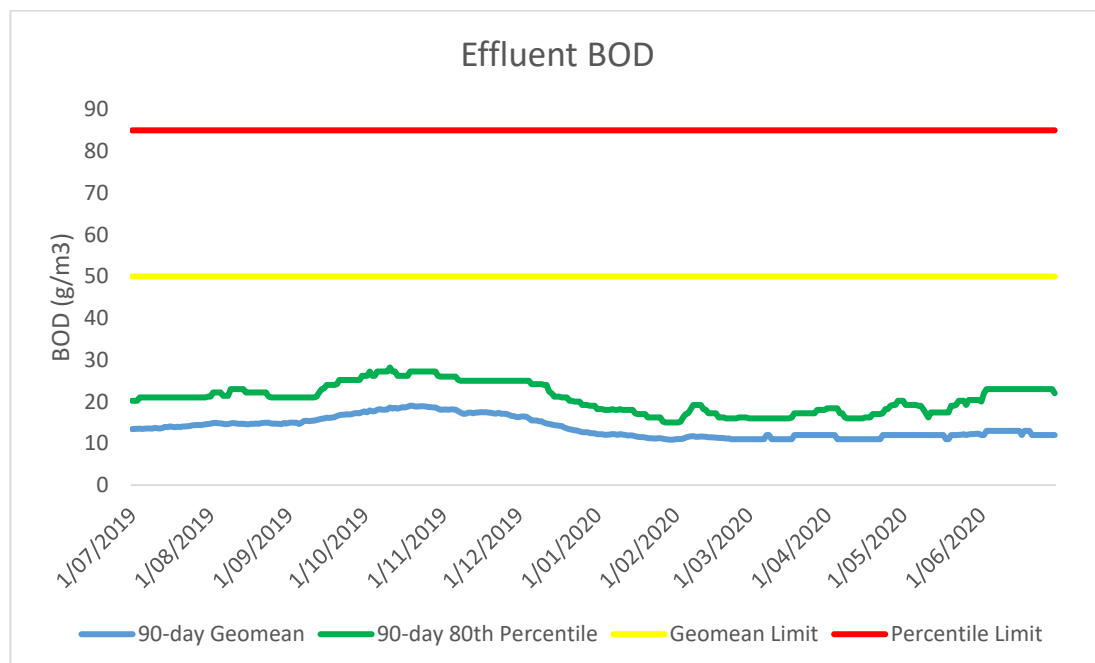
Chart 2: Effluent CBOD5 Summary

Below is a summary of the 90-day geometric mean and 90-day 80th percentile for the effluent Carbonaceous Biochemical Oxygen Demand (cBOD5). The facility has been compliant to cBOD5 requirements this FY2019/2020. Daily values can be viewed in the quarterly reports.

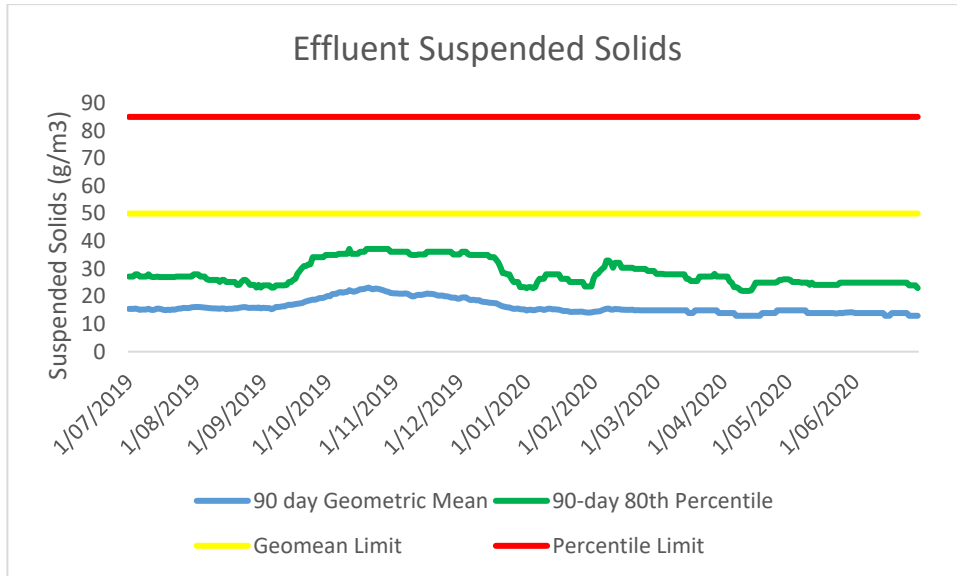
Chart 3: Effluent TSS Summary

Below is a summary of the 90-day geometric mean and 90-day 80th percentile for the effluent total suspended solids. The facility has been compliant to the effluent suspended solids requirements this FY2019/2020. Daily values can be viewed in the quarterly reports.

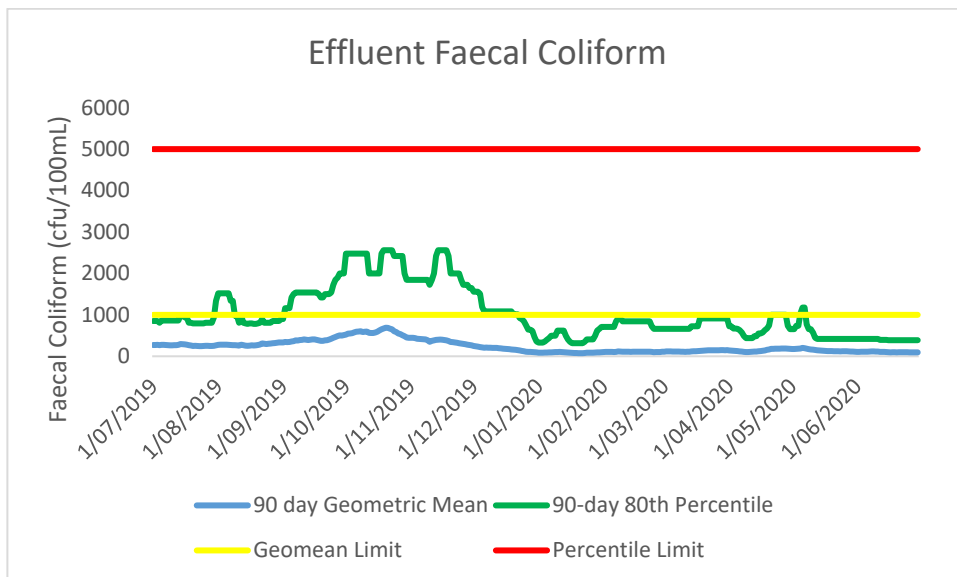
Chart 4: Effluent Faecal Coliform Summary

Below is a summary of the 90-day geometric mean and 90-day 80th percentile for the effluent faecal coliform. The facility has been compliant to the effluent faecal coliform requirements this FY2019/2020. Daily values can be viewed in the quarterly reports.

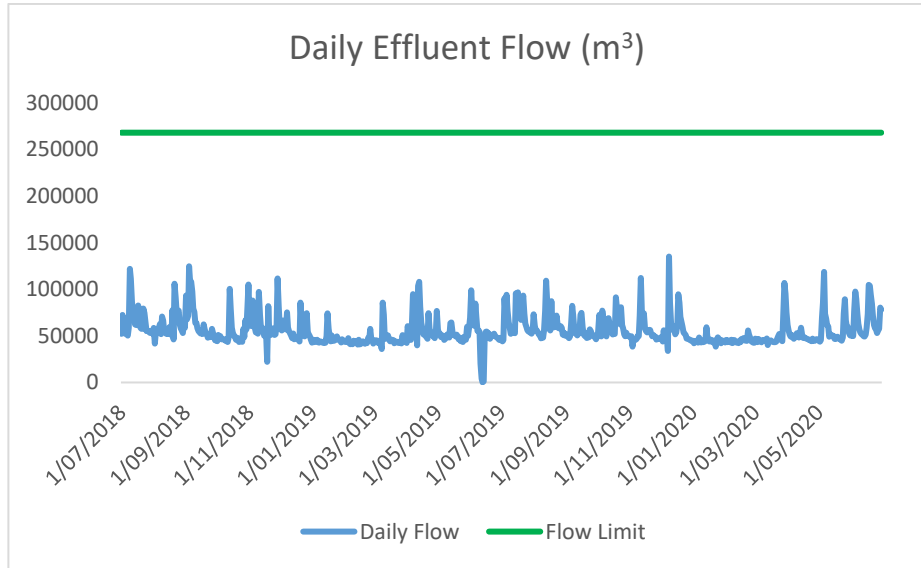
Chart 5: Effluent Flow

Below is the comparison of the effluent flow rates in the previous reporting period. The flows has been similar from the previous financial year.

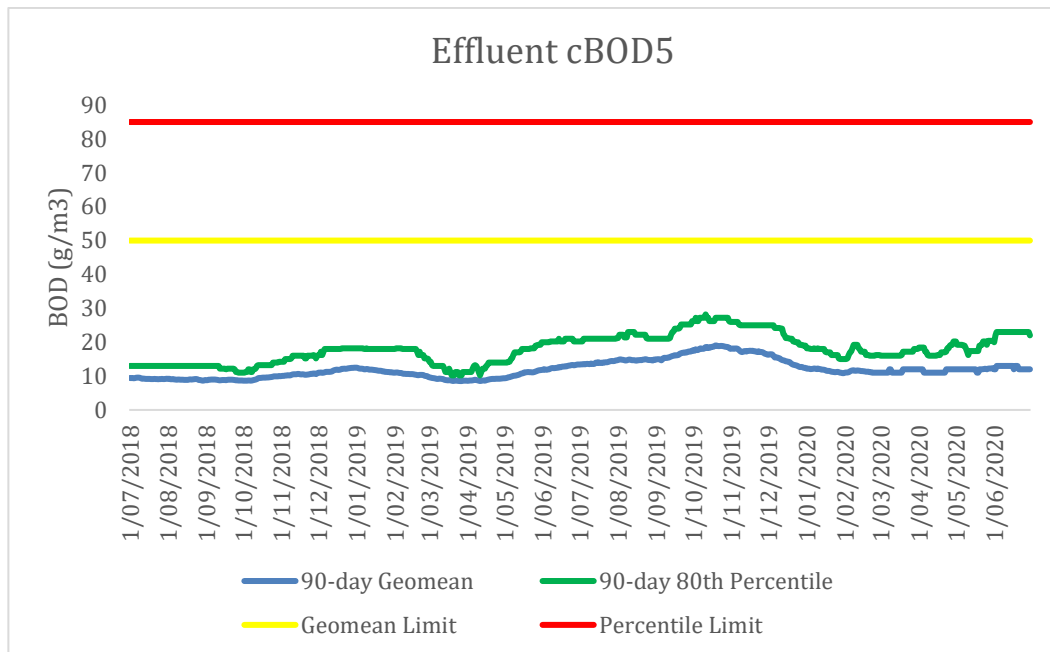
Chart 6: Effluent cBOD5

Below is the comparison of the effluent cBOD5 in the previous reporting period. The effluent cBOD5 continues to be below the resource consent limits.

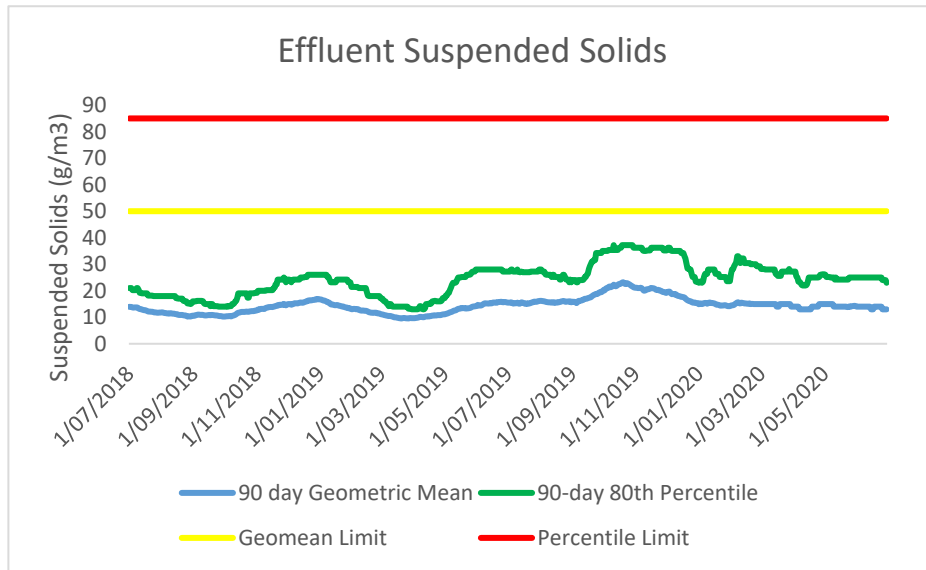
Chart 7: Effluent Suspended Solids

Below is the comparison of the effluent total suspended solids in the previous reporting period. The effluent total suspended solids continues to be below the resource consent limits.

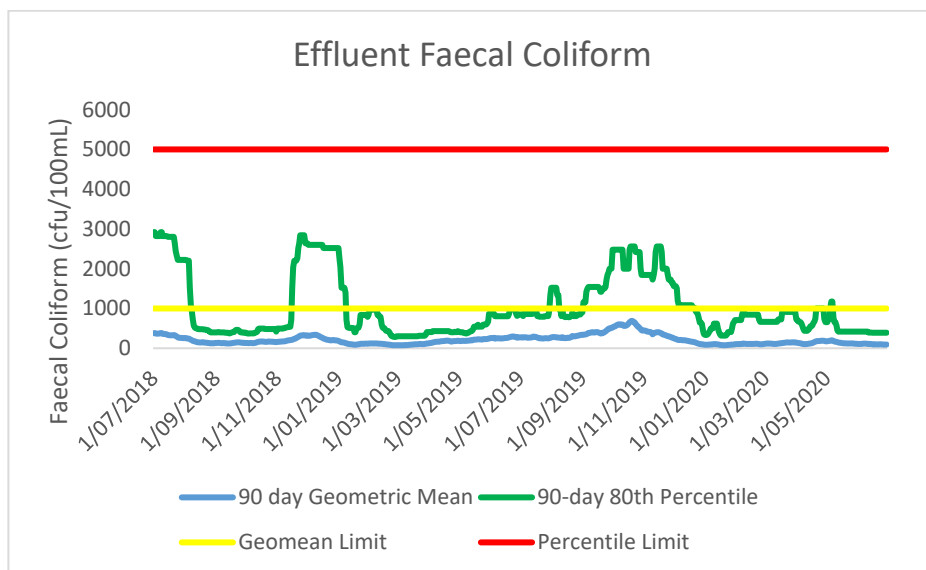
Chart 8: Effluent Faecal Coliforms

Below is the comparison of the effluent faecal coliform in the previous reporting period. The effluent faecal coliform continues to be below the resource consent limits.

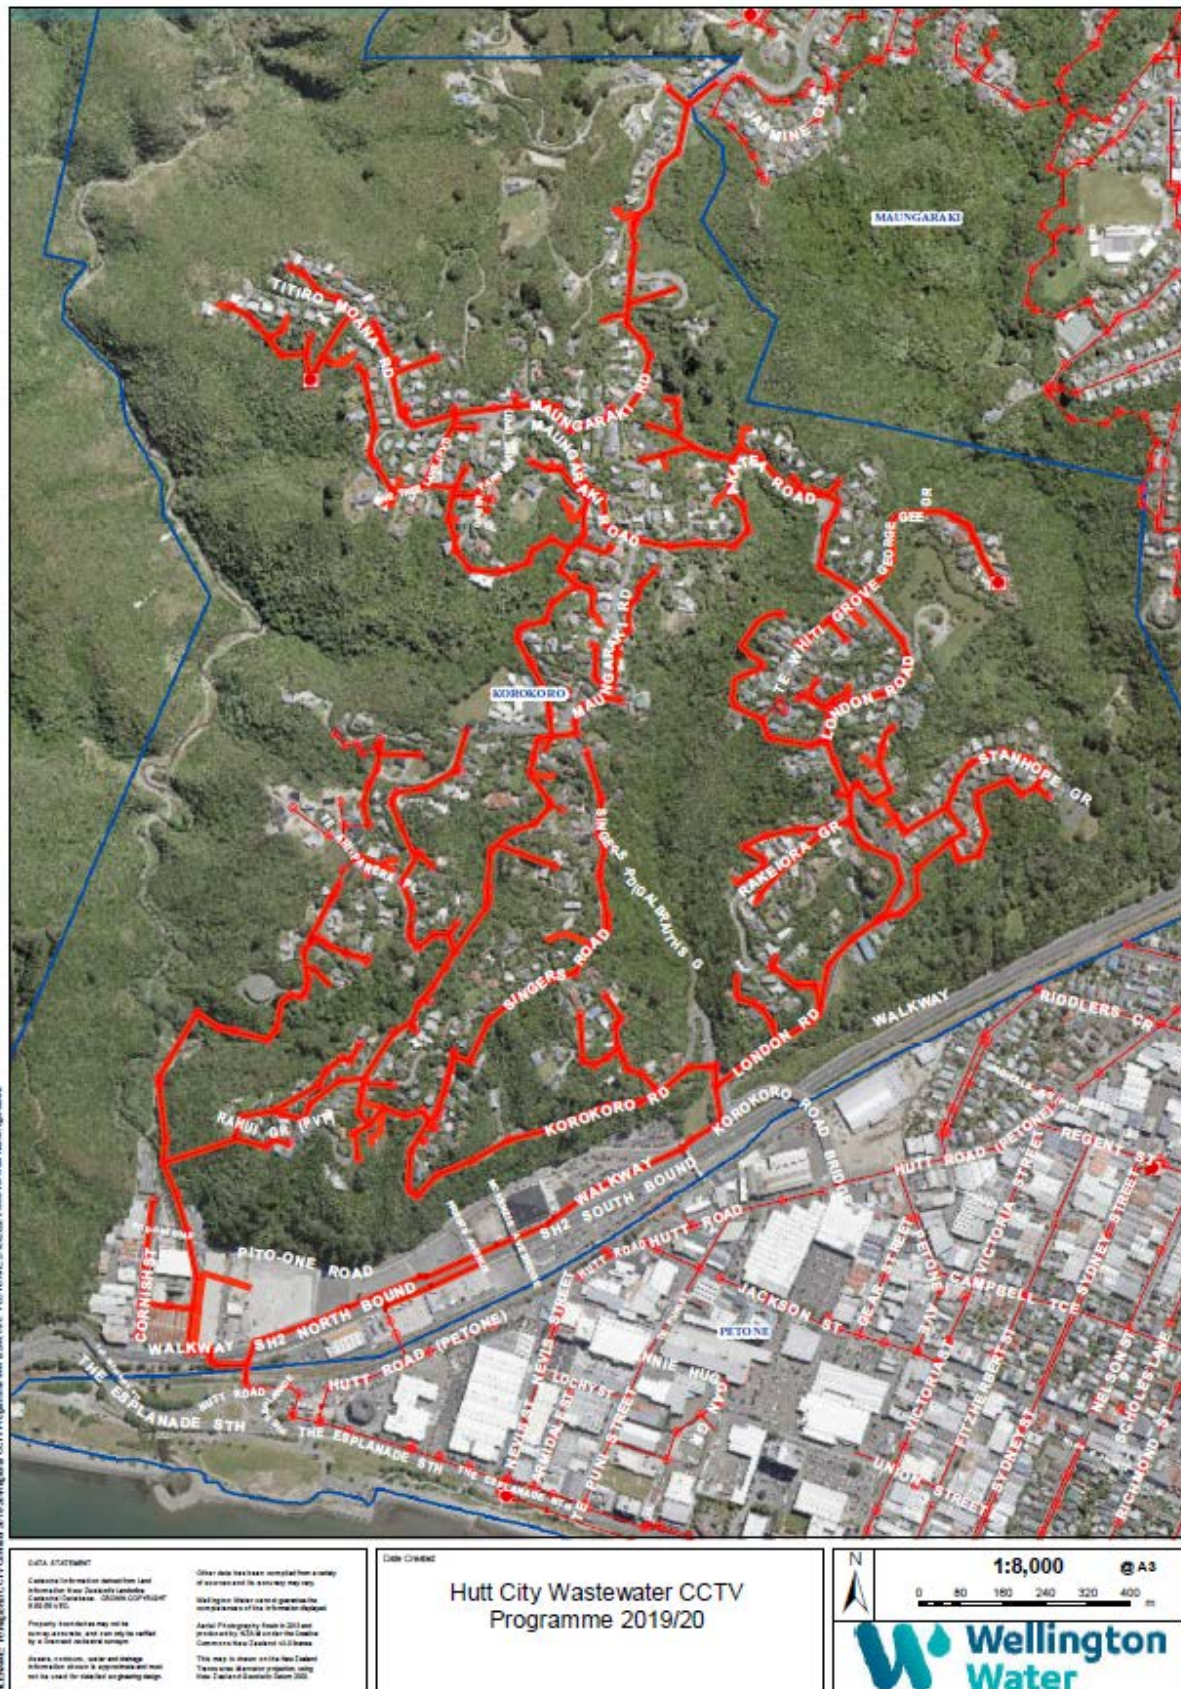
Figure 2 - Map of CCTV of Wastewater Mains completed in HCC in 2019-2020

CCTV of wastewater networks are an ongoing program with 16.3km of CCTV inspections carried out in 2019-2020 and 15.3km of CCTV of wastewater networks planned for 2020-2021. Figure 1 shows a map of the wastewater mains surveyed in 2019-2020 financial year. Figure 2 shows a map of the wastewater mains planned for 2020-2021 financial year. The CCTV footage is used to identify faults and determine the condition of assets.

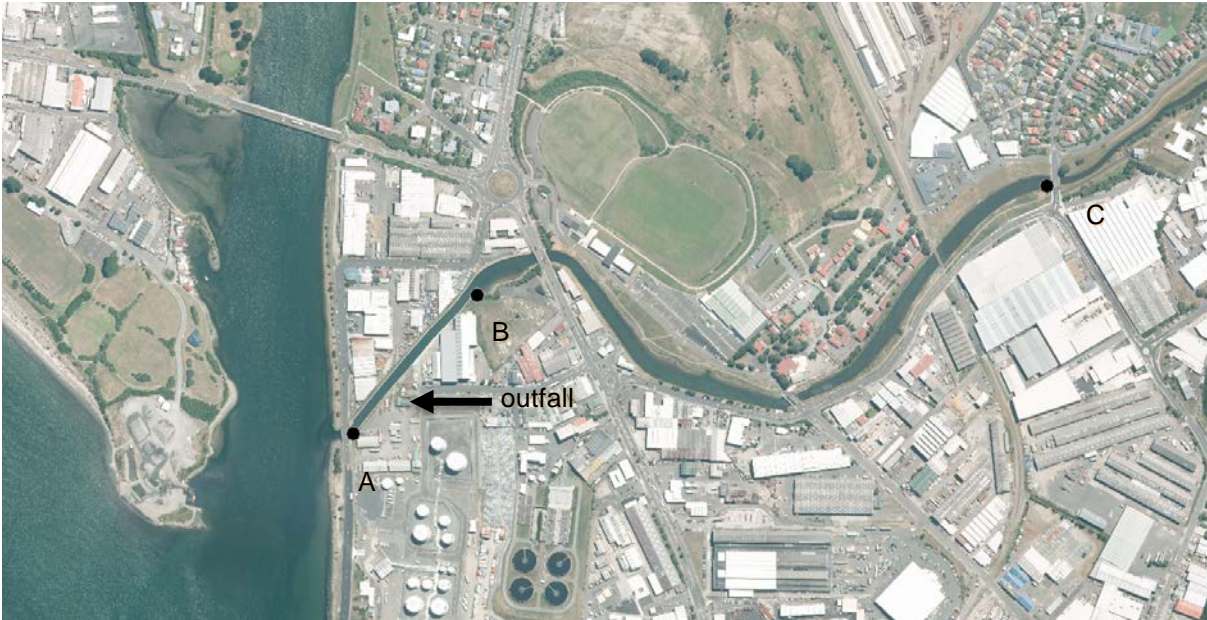
Site A (Port Road Bridge) is regarded as being downstream of the discharge while Site B (Waiwhetu Pa and urupā) and Site C (Bell Road Bridge) are upstream of the discharge from the outfall (which is indicated with an arrow on Figure 2-1 below).

Figure 2-1: Waiwhetu Stream monitoring locations on true left bank of Waiwhetu Stream

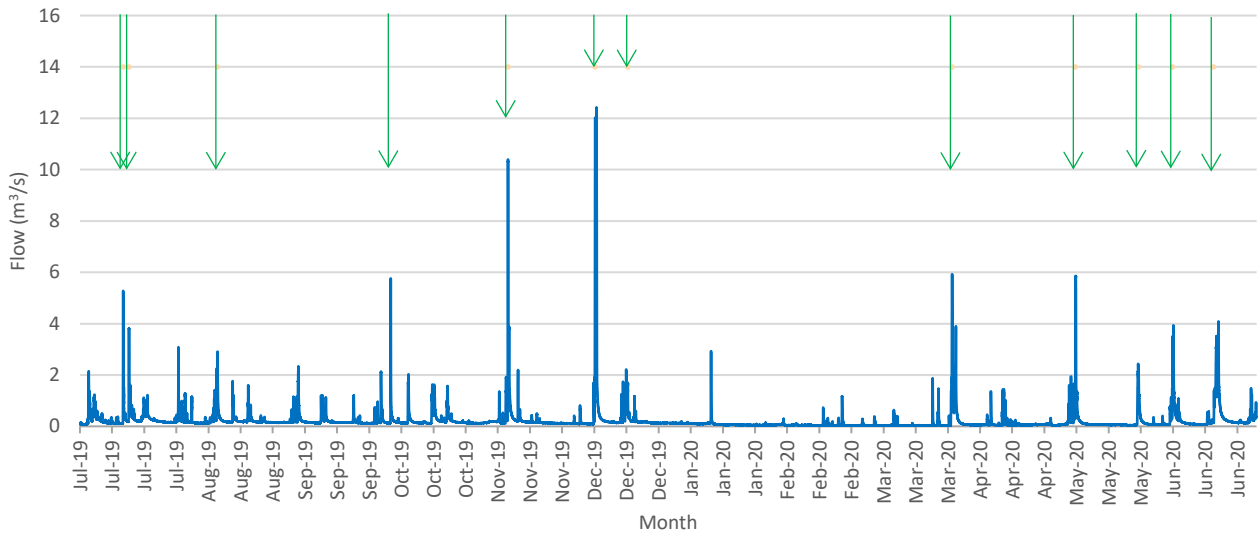
Figure 3-1: Flow in Waiwhetu Stream at Whites Line East during the year from 1 July 2019 to 30 June 2020

HCC operates a flow monitoring station in the lower Waiwhetu Stream near the Seaview outfall, within the tidal zone. Stream flows (m³/sec) during individual discharge events are shown at a higher resolution in Figure A-1 to Figure A-12 in Appendix A. Negative values indicate upstream flow.

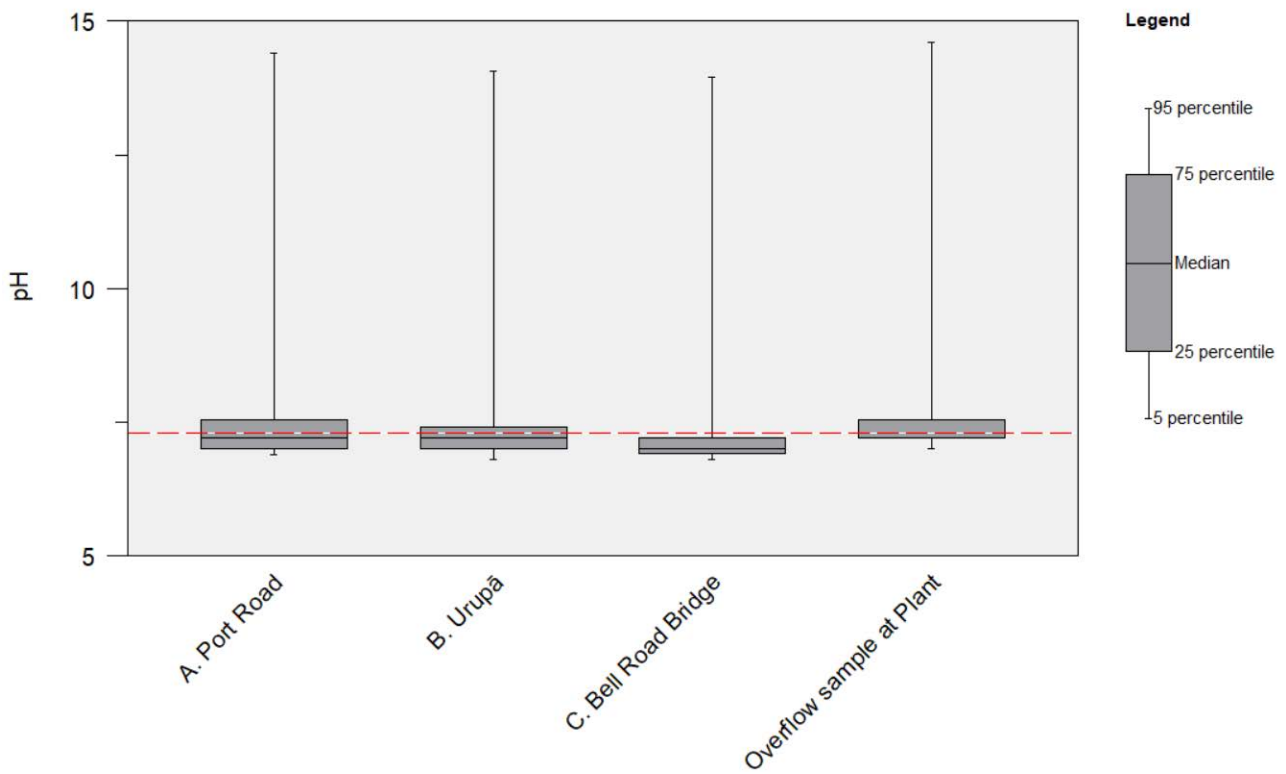
Figure 3-2 Box plot summary of water pH at Waiwhetu Stream site A, B and C and overflow sample at the wastewater treatment plant (N=25).

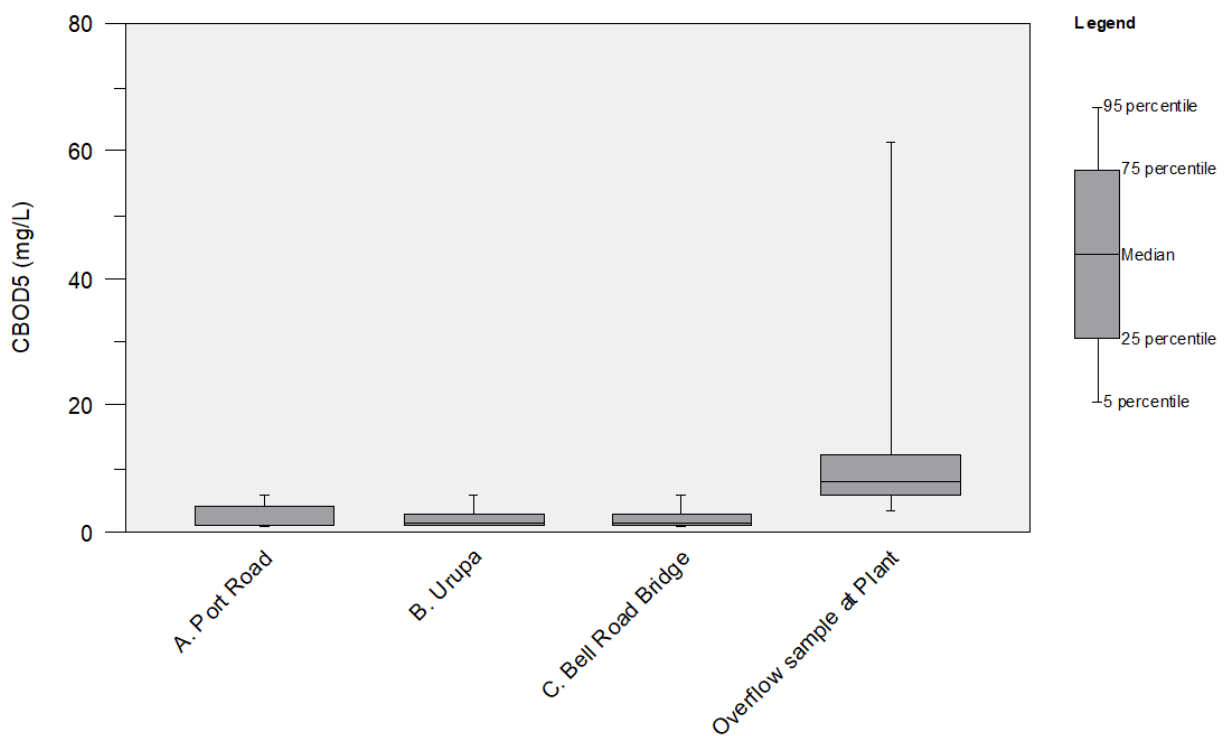
Figure 3-5 Box plot summary of CBOD₅ at Waiwhetu Stream site A, B and C and overflow sample at the wastewater treatment plant (N=25).

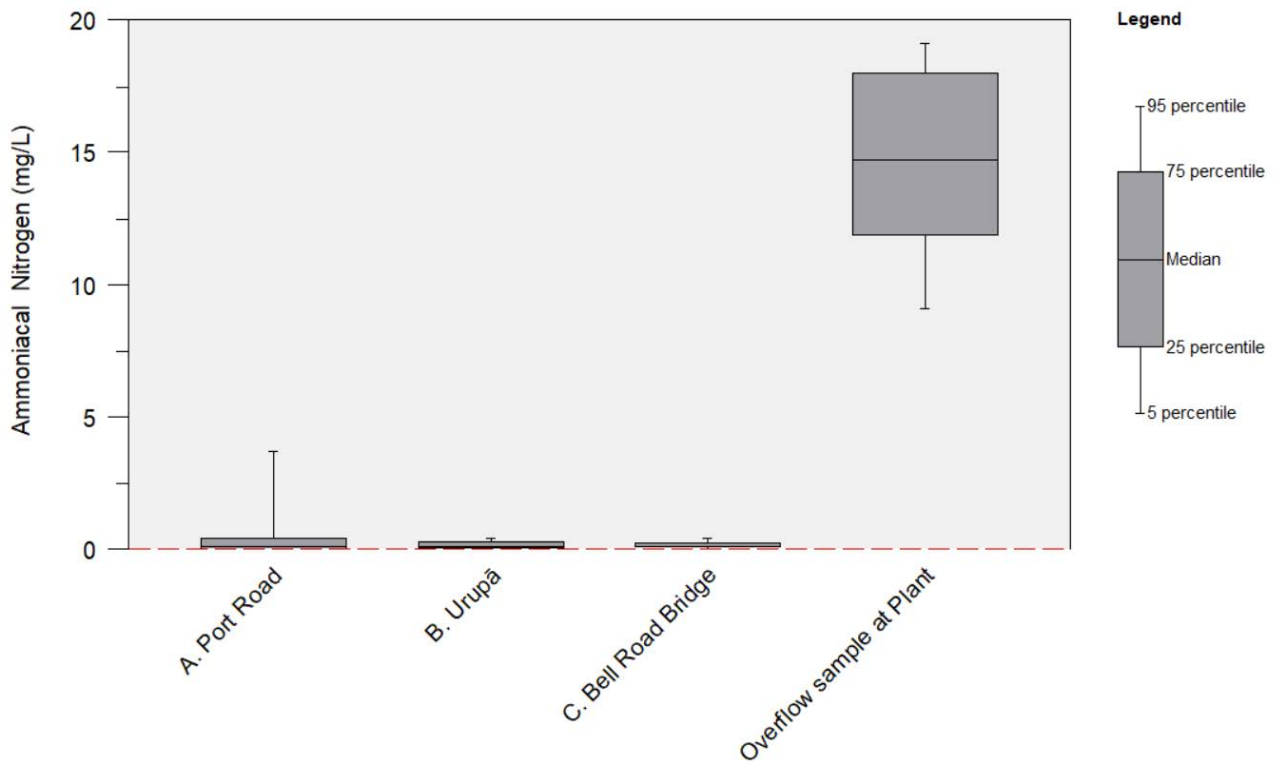
Figure 3-6 Box plot summary of ammoniacal-N at Waiwhetu Stream site A, B and C and overflow sample at the wastewater treatment plant (N=25).

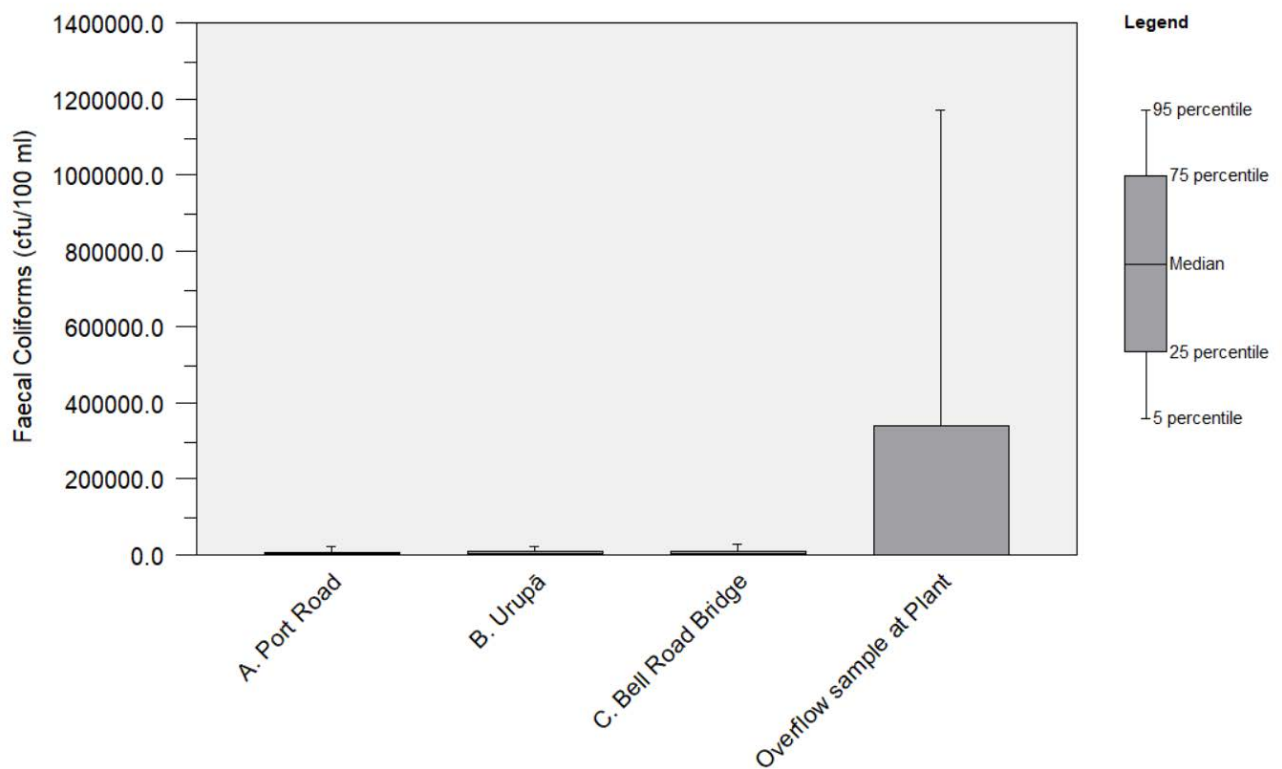
Figure 3-11 Box plot summary of faecal coliforms at Waiwhetu Stream site A, B and C and overflow sample at the wastewater treatment plant (N=25).

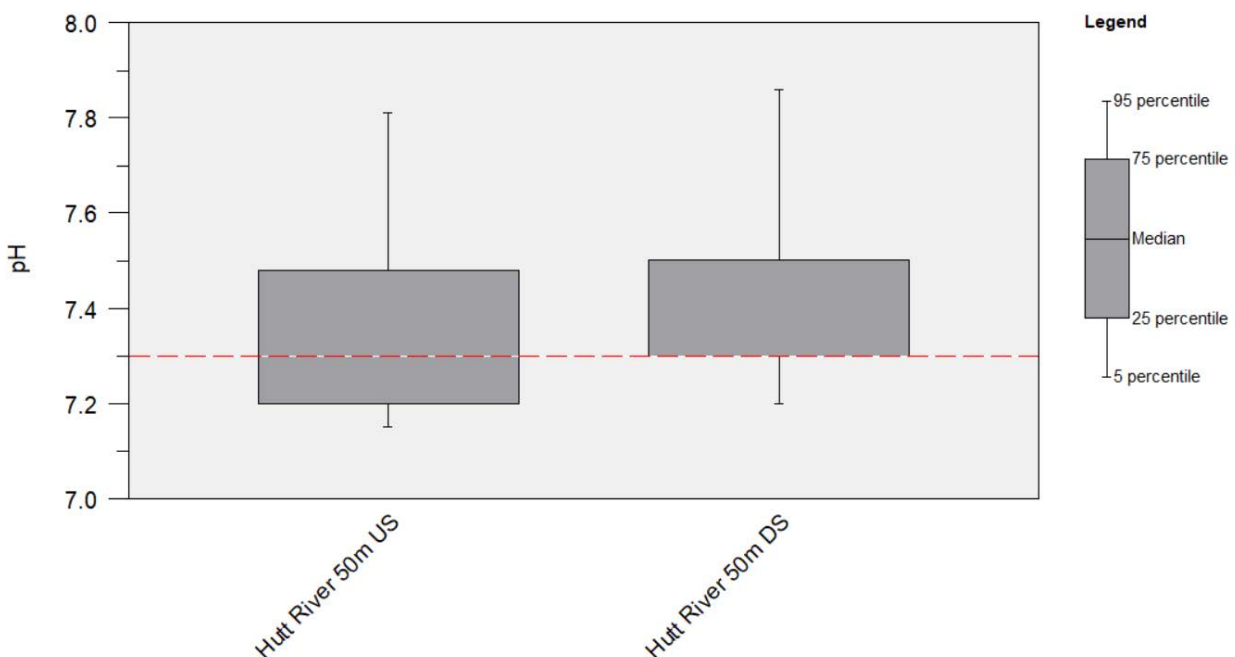
Figure 3-14 Box plot summary of pH at Hutt River sites

There was no observable difference between upstream and downstream Hutt River water quality samples. Combined water quality results during discharge events are summarised by site in box plots Figure 3-14 to Figure 3-21.

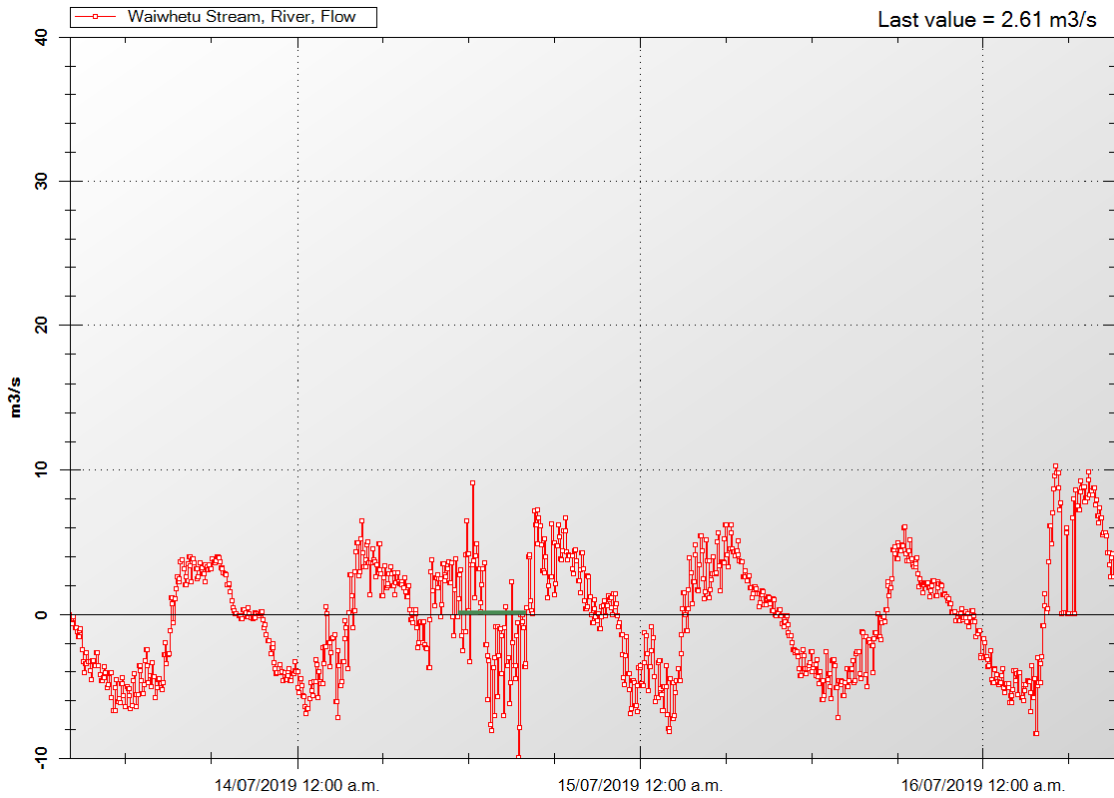
Figure A-1: Flow at lower Waiwhetu Stream near the Seaview outfall during 14 July 2020 overflow event

On all figures within this Appendix, the overflow duration is represented by a green line.
