Subject: Discolouration to the coastal marine area around Rukutane Point on 6th, 7th, and 12th of April 2024

Incident Investigation Report:
UV Transmissivity reduction below the compliance limit
45% (12/04/24 and 13/04/2024)

Incident Investigation Report:
UV Transmissivity reduction below 45% (April 2024)

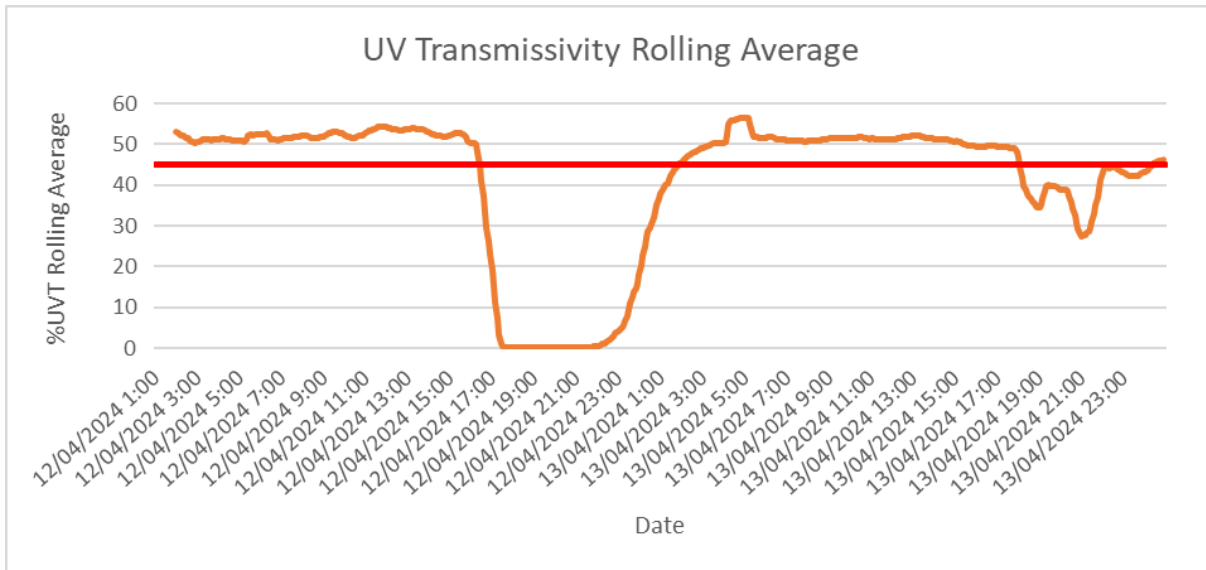
Figure 1: %UVT Rolling Average

Figure 1 shows the period for %UVT decreases on the 12th and 13th of April. The %UVT values were reduced to below 45% on 12th of April between 15:25 and 00:50 am and on 13th April between 17:05 to 23:20 pm.

% UV transmissivity is a real-time indicator of poor effluent quality due to the increased total suspended solids.

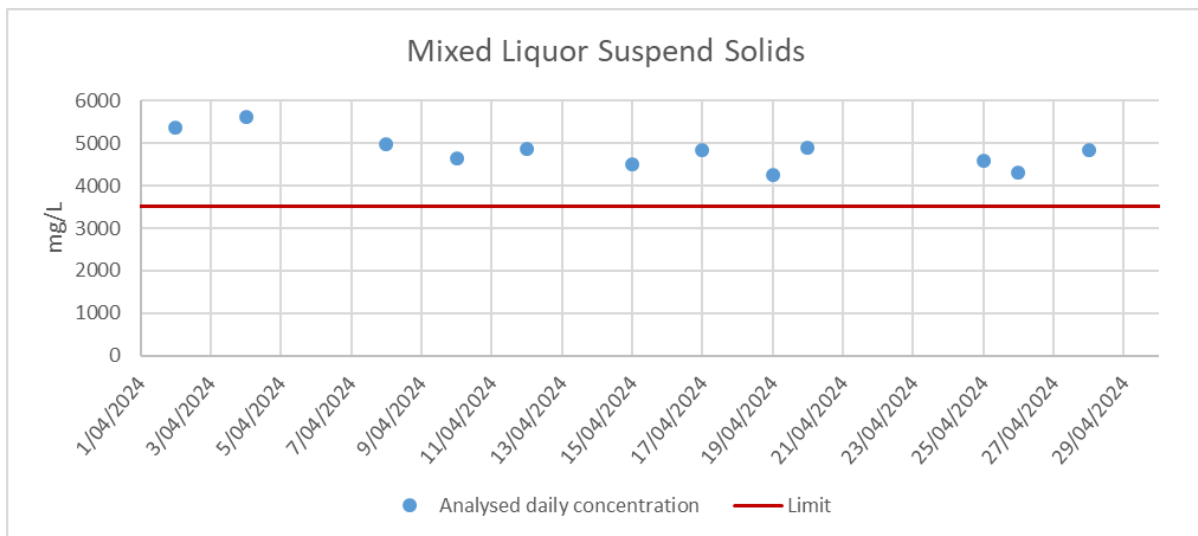
Figure 2

Due to a number of breakdowns of the dewatering system, the MLSS is higher than optimal value (3500 mg/L). See the MLSS values in Figure 2.

The increased flows coupled with a high Mixed Liquor Suspended Solids resulted in low UVT values in the final effluent.

- The increased flows coupled with a high Mixed Liquor Suspended Solids resulted in low UVT values in the final effluent.
- Increased MLSS values are a result of mechanical breakdowns of the sludge dewatering equipment.

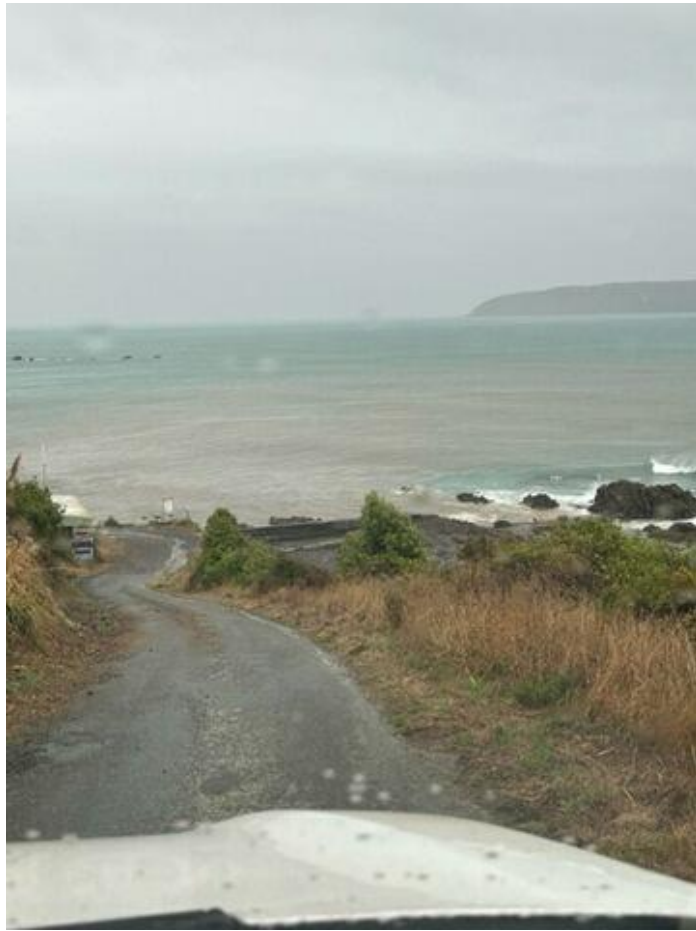
Date: 12/04/2024

Discoloration was observed outside of the 200-metre radius around the outfall.

- Pictures taken of the outfall on April 12th show the discoloration outside of the 200-meters radius. Discoloration observed on April 13th was contained within the 200-meter radius.

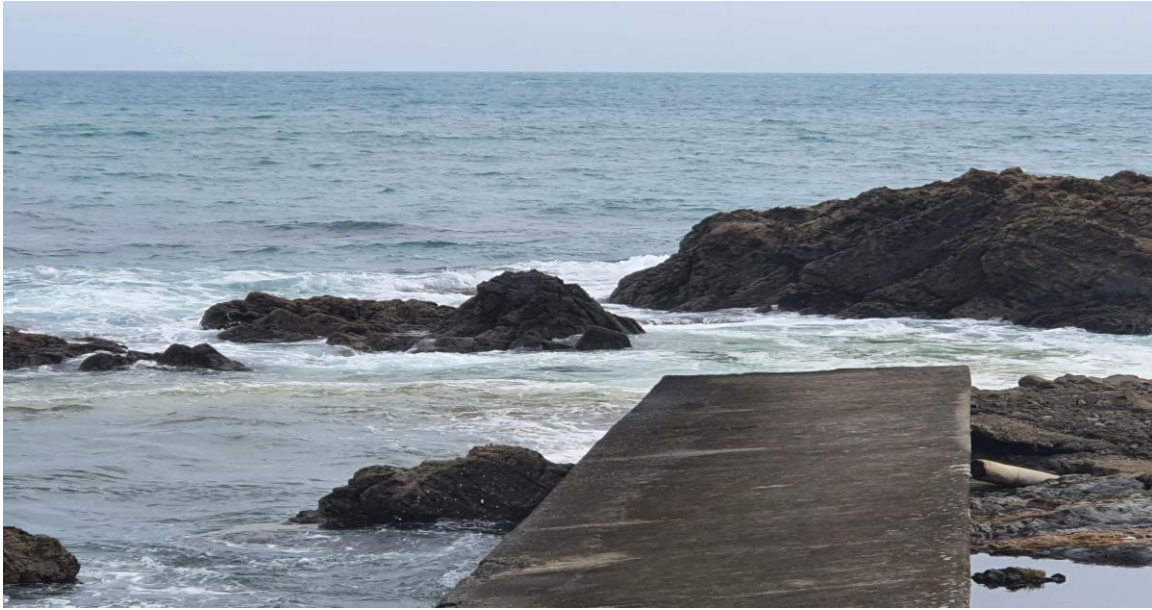
Date: 13/04/2024

Discoloration was limited to the area immediately around the outfall.

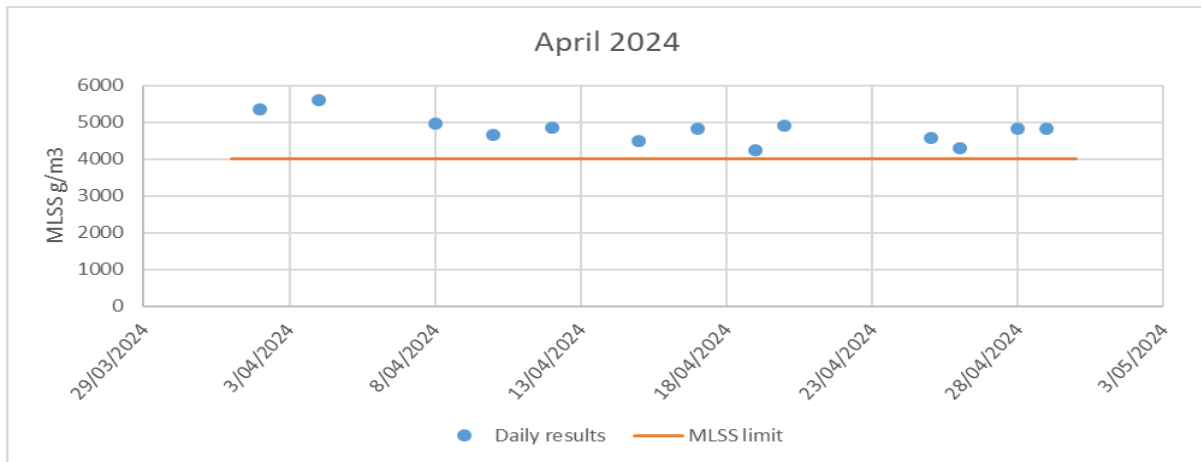
Figure 1 MLSS in April 2024

Date	MLSS g/m3
1/04/2024	
2/04/2024	5370
3/04/2024	
4/04/2024	5620
5/04/2024	
6/04/2024	
7/04/2024	
8/04/2024	4980
9/04/2024	
10/04/2024	4650
11/04/2024	
12/04/2024	4850
13/04/2024	
14/04/2024	
15/04/2024	4500
16/04/2024	
17/04/2024	4830
18/04/2024	
19/04/2024	4240
20/04/2024	4900
21/04/2024	
22/04/2024	
23/04/2024	
24/04/2024	
25/04/2024	4590
26/04/2024	4310
27/04/2024	
28/04/2024	4840
29/04/2024	4840
30/04/2024	
Optimum range	3500-4000

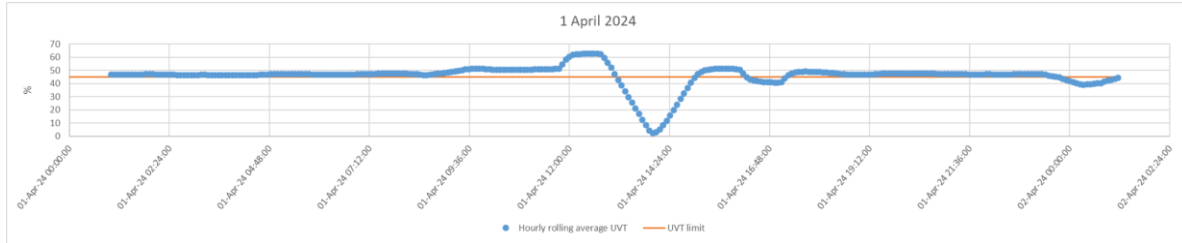
Figure 2 UVT Values on 1 April

Results for daily effluent analysis show good effluent quality. TSS (24-hour flow-proportional sample) were in a normal range (6 g/m³) and UVT value was of 61% (morning grab sample).

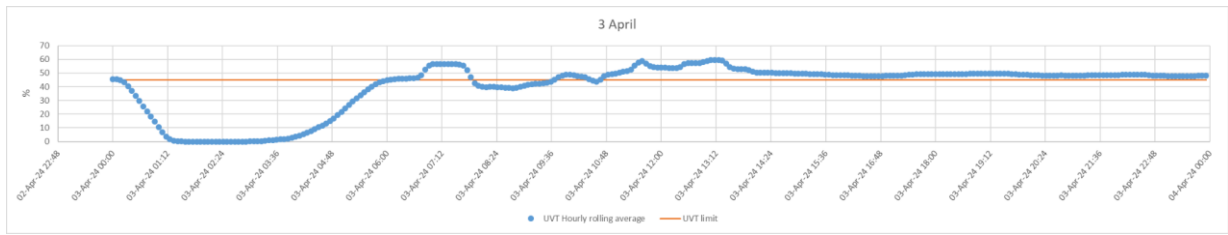
Figure 5 UVT Values on 3 April

Results for daily effluent analysis show increased concentration of TSS (73 g/m³) in the final effluent (24 hour flow-proportional sample) and UVT value was 57% (morning grab sample).

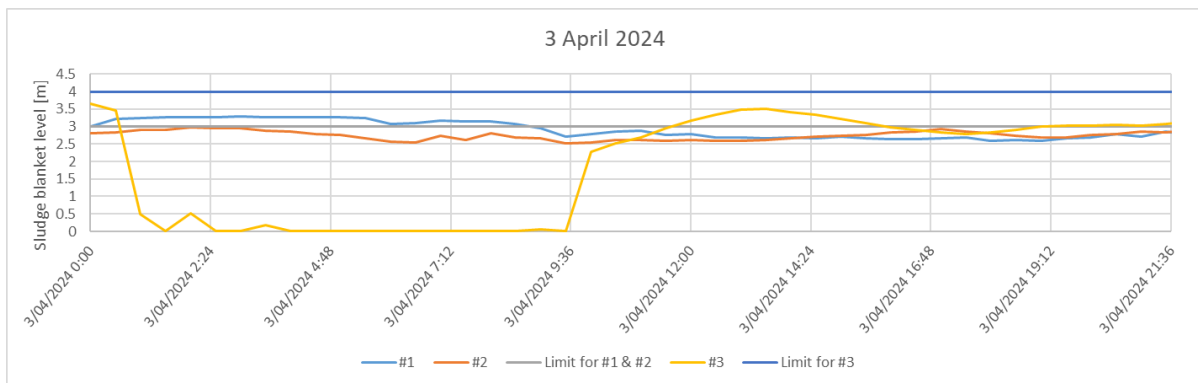
Figure 7 Sludge blanket levels on 3 April

During the period of low UVT values, the sludge blanket levels in clarifiers #1 and #2 exceeded the maximum limits indicating solids carry-over into the final effluent. This aligns with the TSS analytical results from 3 April. Pictures of the outfall vicinity were taken and are attached in [Appendix I-Photos](#). No discoloration exceeding 200-metre radius of the outfall was observed. It is important to note that

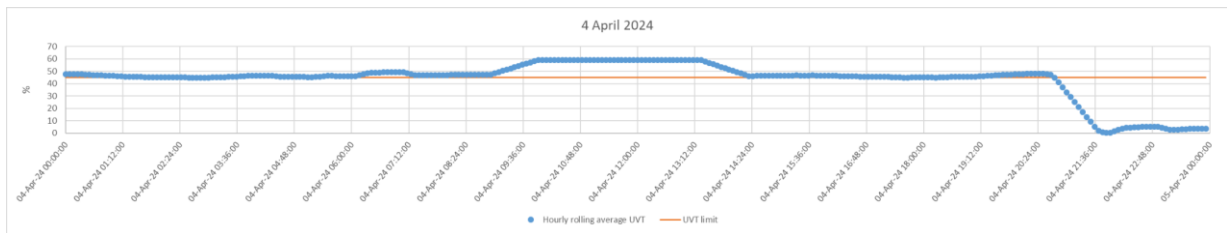
Figure 8 UVT Values on 4 April

Results for daily effluent analysis show increased concentration of TSS (74 g/m³) in the final effluent (24-hour flow-proportional sample) and UVT value was 63% (morning grab sample).

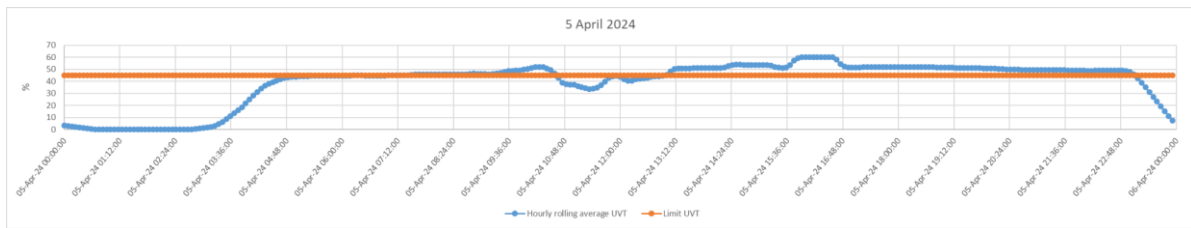
Figure 11 UVT Values on 5 April

Results for daily effluent analysis show good effluent quality. TSS (24-hour flow-proportional sample) were on a high end of a normal range (27 g/m³) and UVT value was 67% (morning grab sample).

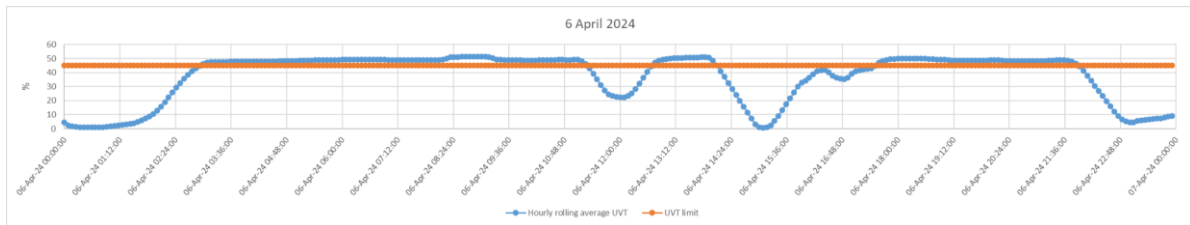
Figure 14 UVT Values on 6 April

Results for daily effluent analysis show increased concentration of TSS (69 g/m³) in the final effluent (24-hour flow-proportional sample) and UVT value was 67% (morning grab sample).

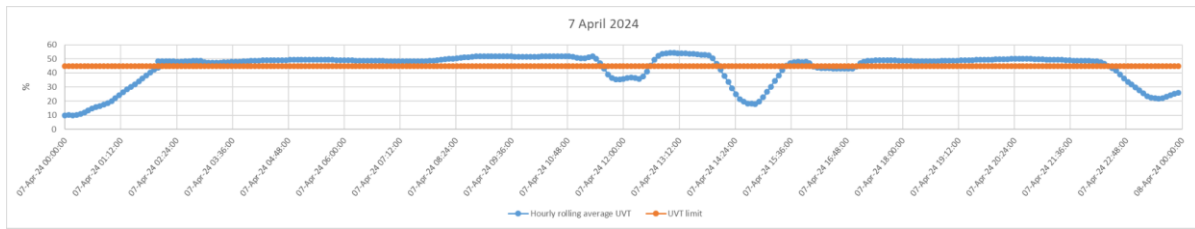
Figure 17 UVT Values on 7 April

Results for daily effluent analysis show good effluent quality. TSS (24-hour flow-proportional sample) were in a normal range (7 g/m³) and UVT value was 65% (morning grab sample).

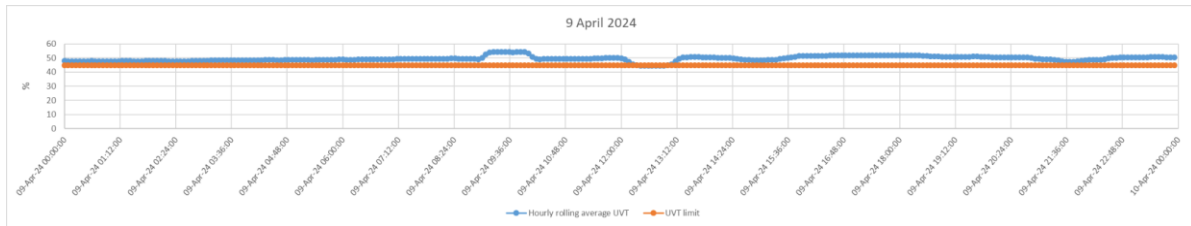
Figure 20 UVT Values on 9 April

Results for daily effluent analysis show good effluent quality. TSS (24-hour flow-proportional sample) were in a normal range (6 g/m³) and UVT value was 66% (morning grab sample).
