Regional Wastewater Services MEETING MINUTES

Date:	02 May 2024
Subject:	Customer Liaison Group meeting – Western Wastewater Treatment Plant
Time:	17:30 pm
Location:	Online -Microsoft Teams
Attendees:	Veolia - Operations Manager & Regional Manager -Wellington WWL - Operations & Asset Advisor, and Wastewater Contracts Administrator Karori Residents Association Representative (KRA) –
Apologies:	Councilors – Community Member/s – Community Member/

Western WWTP Community Liaison Group Meeting

Karori Outfall Repair

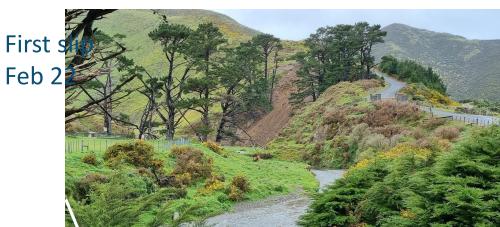
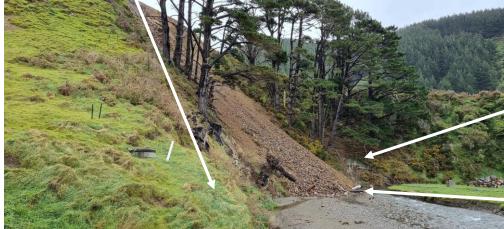
The Karori Outfall pipe which serves the Western WWTP had a broken section discovered in February 2022. A temporary repair was completed in August 2022 but was damaged again within a few weeks due to heavy rainfall.

Existing manhole

Second slip Sept 22

Tunnel Portal

Overflow into stream

Failed pipeline repair

Over the past year, we have been attempting to repair the pipeline, which requires access to private land to complete.

The access agreement has been finally been signed to enable us to re-establish work on the broken Karori Outfall Pipe

The contractor will be remobilising to site in approximately 2 weeks and (weather permitting) we anticipate that the work should be completed by end of Q1 of next financial year.

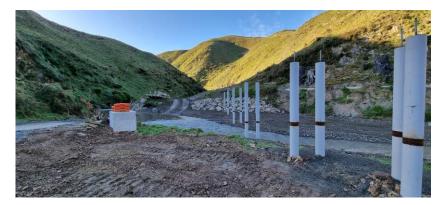
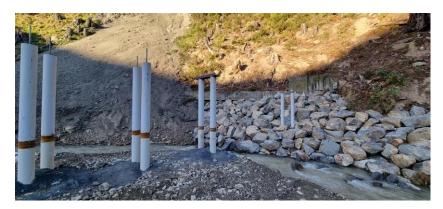
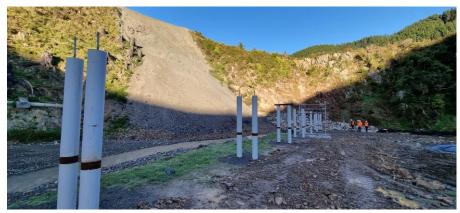
Site on 13th June 2023- day of Stop Works

Karori Outfall Repair - Current State

Majority of work has been delivered, including piling, rip-rap scour protection, hydro-seeding.

Ongoing site and sampling checks still required Approximately 6 weeks of work left including:

- Installing pipeline on piles
- Connecting pipeline
- Site tidy up/reinstatement
