## TRAFFIC MANAGEMENT – Fall from Moving TTM Truck

CAMs #345356

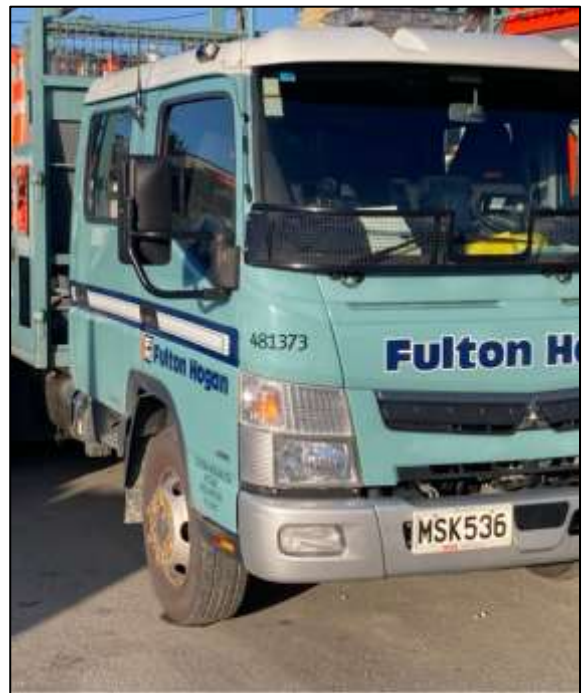
On Friday the 1st of July, at about 3:30am, a traffic management team were packing up their equipment on a work site in the Wairarapa. They'd finished picking up signs and cones on the highway and the truck had looped back to collect the last bits of equipment from a side road.

Two traffic controllers (TCs) were on the back of the truck.

Although both TCs were wearing their harnesses, it appears that at the time of the accident neither TC was tethered to the truck. As the truck has crossed a bridge one of the TCs has fallen from the deck and on to the road.

A number of possible contributing factors have been identified at this early stage. These include:

- Wet weather conditions may have made the truck deck slippery
- The speed of the vehicle at the time of the accident
- Compliance with PPE requirements

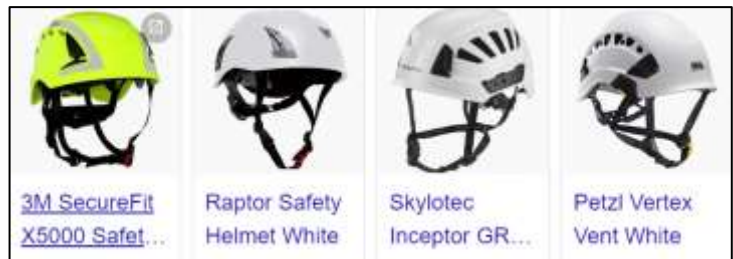
3. Workers on the back of a moving TTM truck deck must wear a hard hat that meets the requirements of EN 12492 and is fitted with a chin strap.
