Traffic Management at Road Closures

CAMs #373388

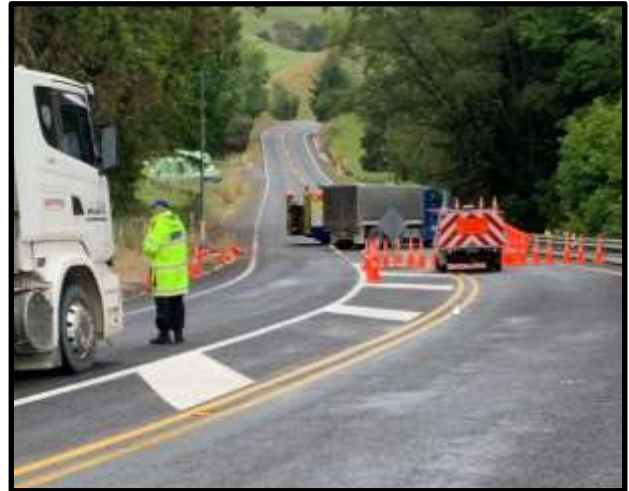
Tragically, just before 08:00am as the 5th truck of the day approached the checkpoint, the traffic controller has stepped out in front of that truck to remove several road cones in front of the exit. The

Western checkpoint, looking west - 12 February 2023

truck driver was unable to avoid the collision and Mr Barnes passed away on site. The truck was doing about 35kmph just prior to the accident.

1. All vehicles, entering and (or) exiting a road closure checkpoint must be required to stop before any action is taken to remove any barrier or gate at the checkpoint. (All).
2. Signage, giving advanced warning of the checkpoint must be provided from all directions including from inside the closure. (All).
3. A 30kmph temporary speed limit must be used in conjunction with any manned checkpoint. (All).
4. Please make sure you have CAPEX allowed in your 2023/24 plans to advance the following previously stated objective: *“to be in a position where every person on a site can communicate by radio with every other person on that site by June 2024”* (Senior Managers).

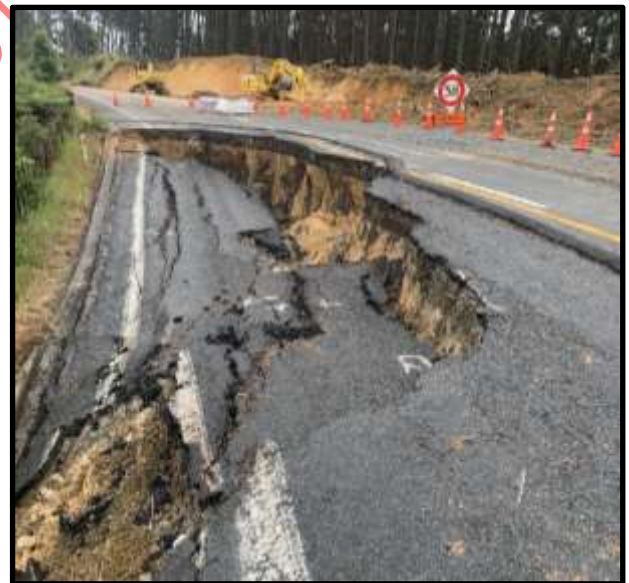
On the 30th of January, during the Auckland storm, signs of a large under-slip started to appear on the State Highway that runs between Hamilton and Raglan.

Slip, looking west - 2 February 2023
