Service Strike – Earthenware Pipe

During a burst water main repair, a worker has cut through an unidentified earthenware pipe striking a live 400V cable encased inside

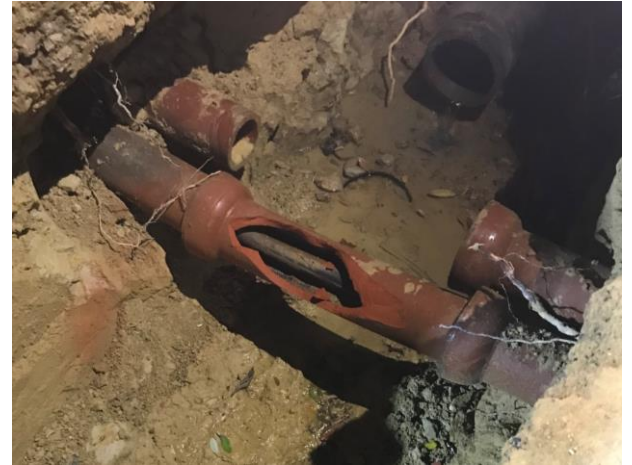
- A water crew discovered 2 unknown earthenware pipes resting on top of a burst water main, assumed to be drainage pipes. This raised concerns regarding a contamination risk to the drinking water network
- A drainage crew attended and decided to remove and replace sections of the unidentified earthenware pipes
- A compact circular saw was used to cut the pipes and struck a live power cable encased inside one
- The utility owner had marked out the power cables shown on their plans but did not scan the full site – the cable within the earthenware pipe was not identified on the plans and not marked out

1. Stop and reassess when discovering anything unknown on site
2. Plans are only an indication of service locations. Fully scan the excavation area before breaking ground
3. If unsure about any pipe, scan it or break it open instead of cutting it

- Abandoned pipes are used as quick and easy ways to install utility service lines. Treat any abandoned or unknown pipes as if they have service lines running inside them.
