**OIA IRO-391**

**Official information request on Point Howard Slip.**

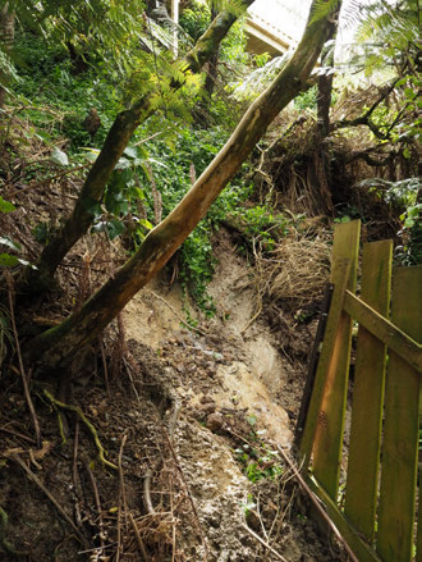
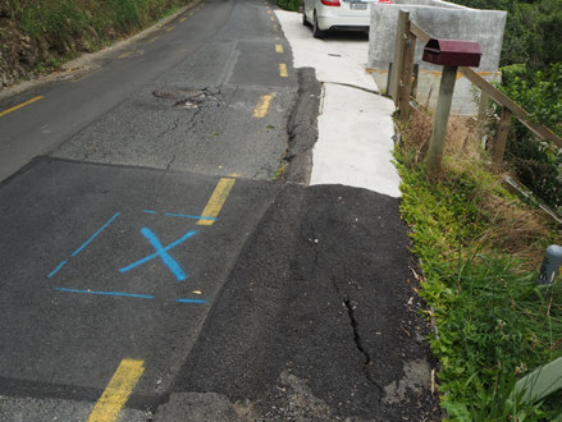
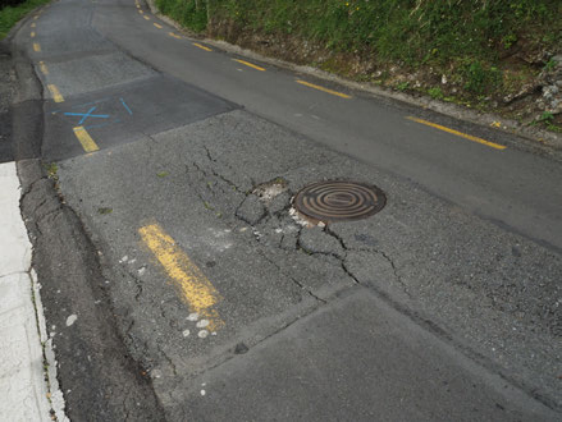
**Pin location picture:**

Thank you for your email summarising my verbal report of the roading problem near 78 Howard Road, Point Howard. The main issues are the settlement of the road surface, continuing damage to the roading pavement and the possible slipping of the downslope edge of the road (see attached Photos Nos 2 & 3). The downslope edge of the road comprises a shallow layer of fill material that has become saturated with water. There is some risk of a significant slip in this material that could damage the services in the road (sewer, water and fibre optic cable) and close the road. Some minor slipping has occurred at a distance of about 10 m below the road where some of the water from the leak is flowing out of the slope (see attached Photo No 1). Howard Road is the only road servicing many properties at the top of Point Howard and loss of this access would be very disruptive for these residents.

The water leak that has caused the damage to the pavement has been evident for at least three months and the flow has gradually increased until it is in excess of 100 litres per minute. It has previously been reported to Wellington Water who have inspected it but apparently have not given fixing it high priority (possibly because it is not visible from the road). If it continues the damage to the pavement and services could become costly to reinstate.

The water flowing from the leak has completely saturated an unoccupied private property at the base of the slope and flows down a usually dry stream bed into the harbour.

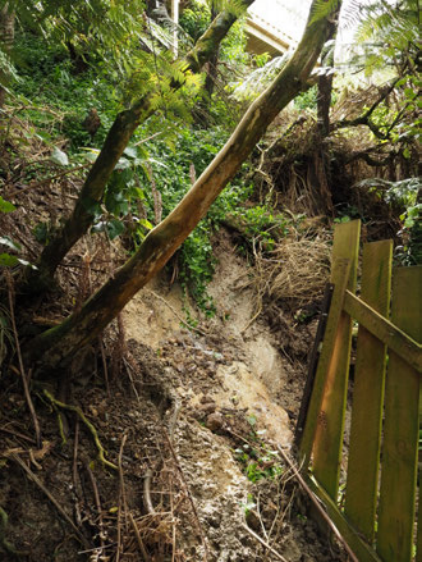
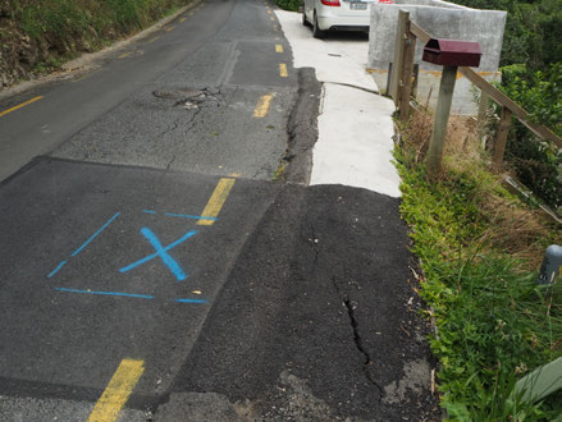
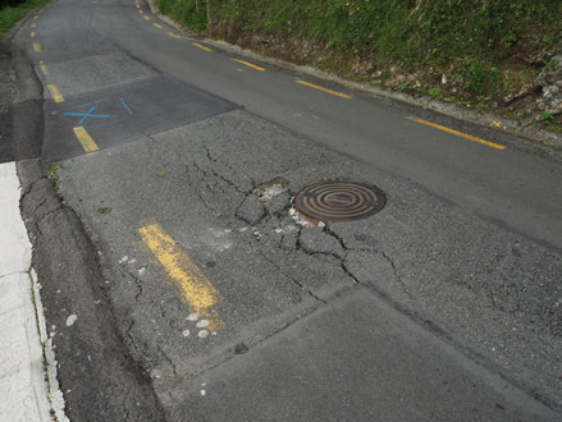
**Pin location picture:**

Thank you for your email summarising my verbal report of the roading problem near 78 Howard Road, Point Howard. The main issues are the settlement of the road surface, continuing damage to the roading pavement and the possible slipping of the downslope edge of the road (see attached Photos Nos 2 & 3). The downslope edge of the road comprises a shallow layer of fill material that has become saturated with water. There is some risk of a significant slip in this material that could damage the services in the road (sewer, water and fibre optic cable) and close the road. Some minor slipping has occurred at a distance of about 10 m below the road where some of the water from the leak is flowing out of the slope (see attached Photo No 1). Howard Road is the only road servicing many properties at the top of Point Howard and loss of this access would be very disruptive for these residents.

The water leak that has caused the damage to the pavement has been evident for at least three months and the flow has gradually increased until it is in excess of 100 litres per minute. It has previously been reported to Wellington Water who have inspected it but apparently have not given fixing it high priority (possibly because it is not visible from the road). If it continues the damage to the pavement and services could become costly to reinstate.

The water flowing from the leak has completely saturated an unoccupied private property at the base of the slope and flows down a usually dry stream bed into the harbour.
