**OIA IRO-269**

### Stormwater Investigations - Infrastructure Checks in Your Neighbourhood

Regarding Property: 18 Creswick Terrace, Northland, Wellington

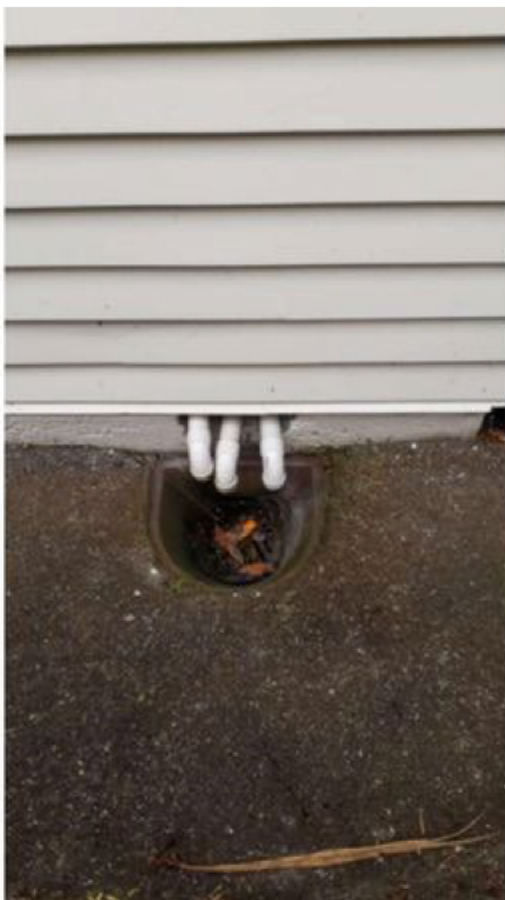
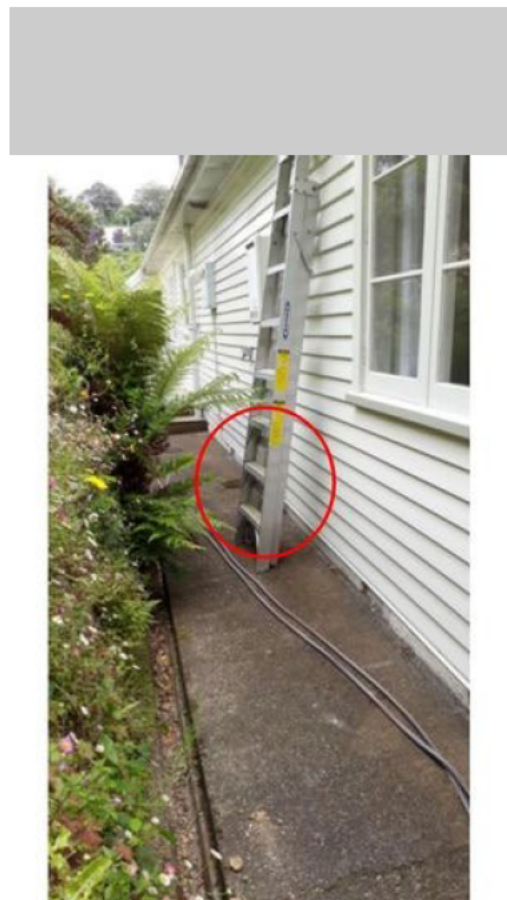
Photo/s of Faults:

- 1× Low gully trap on a paved area (less than 25mm)  
- LETS STORMWATER INTO WASTEWATER NETWORK

Build up the height of the gully trap surround to a minimum height of 25mm on a paved surface (path or driveway etc). This can be done with concrete mortar or by fitting a premade concrete surround and sealing it in place. Wellington Water is aware that premade concrete surrounds can be purchased at Humes and Hynds plumbing suppliers (not currently stocked at DIY stores).
