OIA IRO-269

Stormwater Investigations - Infrastructure Checks in Your Neighbourhood

Regarding Property: 18 Creswick Terrace, Northland, Wellington

Fault Record and Repair Recommendation/s:

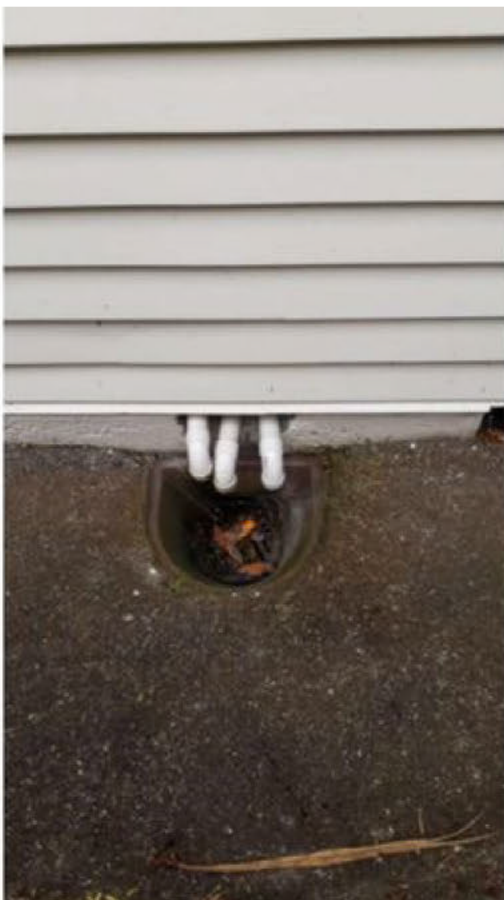
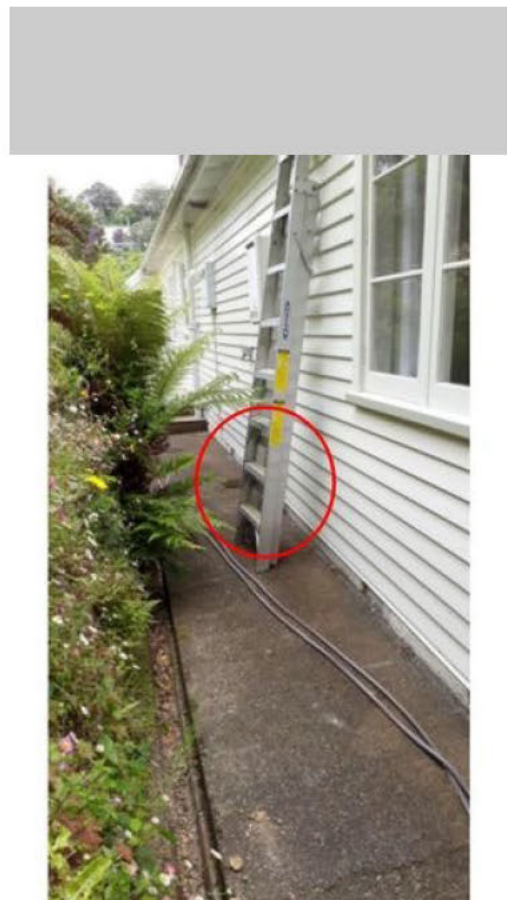
Photo/s of Faults:

- 1× Low gully trap on a paved area (less than 25mm)
- LETS STORMWATER INTO WASTEWATER NETWORK

Build up the height of the gully trap surround to a minimum height of 25mm on a paved surface (path or driveway etc). This can be done with concrete mortar or by fitting a premade concrete surround and sealing it in place. Wellington Water is aware that premade concrete surrounds can be purchased at Humes and Hynds plumbing suppliers (not currently stocked at DIY stores).
